Packet Guide City of Charlottesville Board of Architectural Review Regular Meeting November 15, 2022, 5:30 p.m. Hybrid Meeting (In-person at CitySpace and virtual via Zoom)

Preston Place, TMP 050118001 and 050118002
     Rugby Road-University Circle-Venable ADC District
     Owner: Sue and Steve Lewis
     Applicant: Leigh Boyes, Sage Designs
     Project: Landscaping
  - 2. <u>Certificate of Appropriateness</u>

BAR # 22-11-02 480 Rugby Road, TMP 090003000 Rugby Road-University Circle-Venable ADC District Owner: Westminster Presbyterian Church Applicant: Breck Gastinger, Local Design Collective Project: Landscaping, site work (Common Grounds)

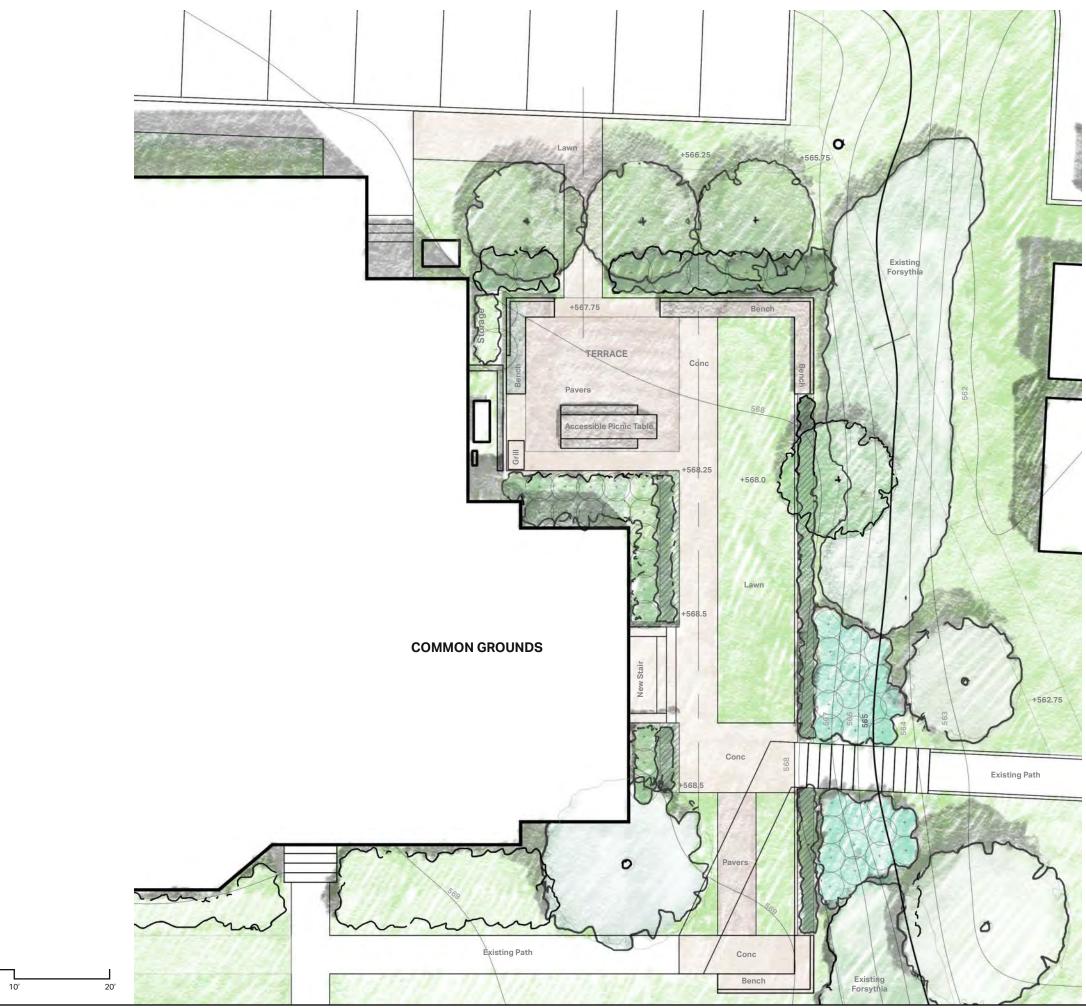
- ٠ Forsythia only removed on either side of stair.
- Provide bench backs along portions of bench ٠
- Concrete below benches (included in totals) ٠ provides edge to pavers and lawn.
- Pavers to be concrete, permeable paver system ٠ set on clean, angular gravel per manufacturer recommendation. Slope subsurface away from building and provide 4" perforated draintile for any overflow.
- ٠
- Rebuild existing concrete stair to Common Grounds Porch on top of existing stair. Freestanding wood screen/fence provides storage, hides building utilities. 5/4 x 6 wood slats on treated posts. Full 2" x 8" cap. Boards to be prepainted.
- Provide tree/shrub planting and prepare beds at ٠ front of plantings. Annual/perennials by WPC. Benches:
  - Painted steel bases and back supports ٠
  - Rot-resistant native timber locust or equal ٠
  - Corrosion resistant fasteners ٠

The new project also improves accessibility throughout the Westminster campus. A rebuilt stair at the porch entrance improves safety and repairs a rotting sill condition. The existing concrete stair will remain, with a new stair and landing constructed on top.

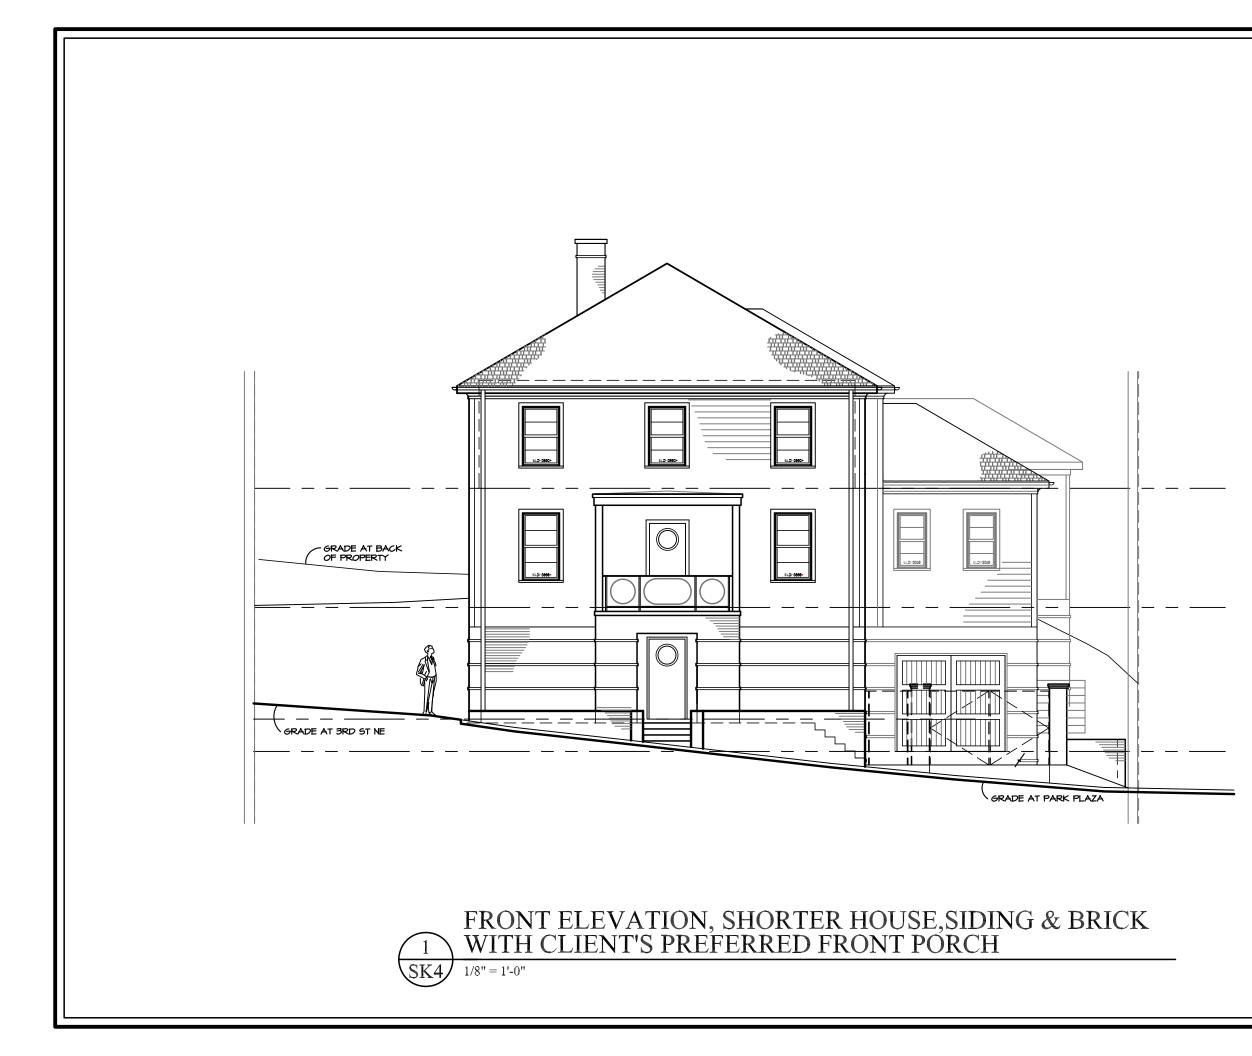
- 1. SK4 (7) sheets showing
  - a. Shorter front and side elevation
  - b. Three front porches
  - c. Front gate detail
- 2. SK4 Addendum
  - a. Street profile diagram

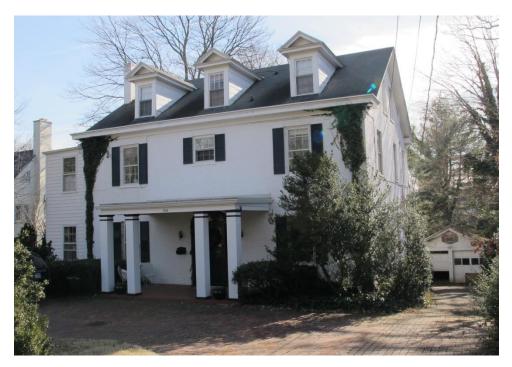
### 914 Rugby Road

### Date: 1921 ca. (not on 1920 Sanborn map) District Status: Contributing Resources: 1 Single Dwelling (c); 1 Garage (c); 1 pool (c) Style: Colonial Revival

**Architectural Description:** The side-gabled, 2.5-story, stretcher-bond brick veneer dwelling stands three bays wide and two bays deep. Symmetrically fenestrated, the facade features a central entrance flanked by 6/6 wood windows. The entrance is sheltered by a single-bay shed-roofed porch with sturdy, paired Tuscan post supports and a molded wood cornice. A fanlight transom and sidelights details the entry. Three 6/6 wood windows pierce the second story, with the central window smaller in size. Each window features fixed louvered shutters, square-edged sills, and a thin, molded wood surround. The upper windows feature rowlock brick lintels. A molded wood cornice with returns details the asphalt-shingled roof that is pierced with three attenuated gabled dormers. Each wood-frame dormer is lit with a 6/6 window and capped by prominent pedimented gable peak with boxed cornice and closed tympanum. An exterior-end and an interior-end brick chimney each rose from the roof. A two-story shed wing was added to the north corner of the dwelling. It features vinyl siding and 6/6 wood windows. A small sunporch addition was also added to the rear elevation, which is accessed by an exterior wood stair with portico.

**Site Description:** Set on a narrow, .48-acre rectangular parcel, the dwelling faces Rugby Road. A circular brick driveway extends across the front of the dwelling, with a spur extending along the side to a garage. The slightly sloping property features a small, grassy lawn, mature trees and shrubs, and some foundation landscaping. A fenced rear yard features a grassy lawn and an in-ground pool. The property line to the rear is wooded.

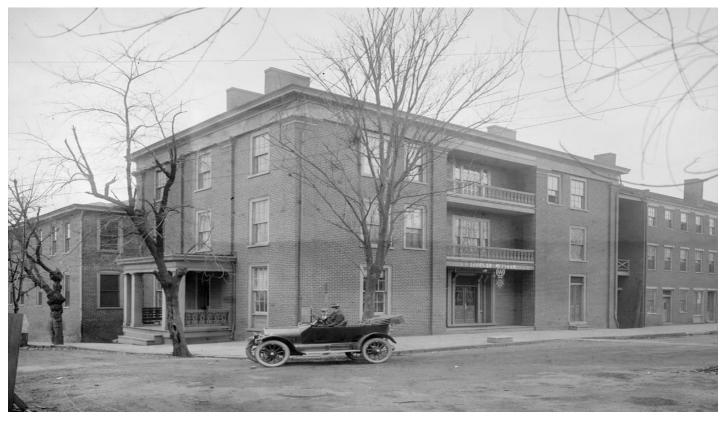
PHOTO SHOWING THREE OF THE ADDED WINDOWS (PHOTO 20) AND THE ORIGINAL PORTICO

- Install two-story columned portico to match the original one-story portico.
- Portico will surround existing fire escape and continue to serve as an emergency egress. (See photo 10).
- Portico railing to have zig-zag wood railing similar to "The Second Yard" on Market Street (photo 18)
- Install brick handicap ramp that extends from the corner of building to the portico.
- Remove door and steps to right of entry door (photo 19) and replace with historic window that matches the original window (photo 20 of original window)

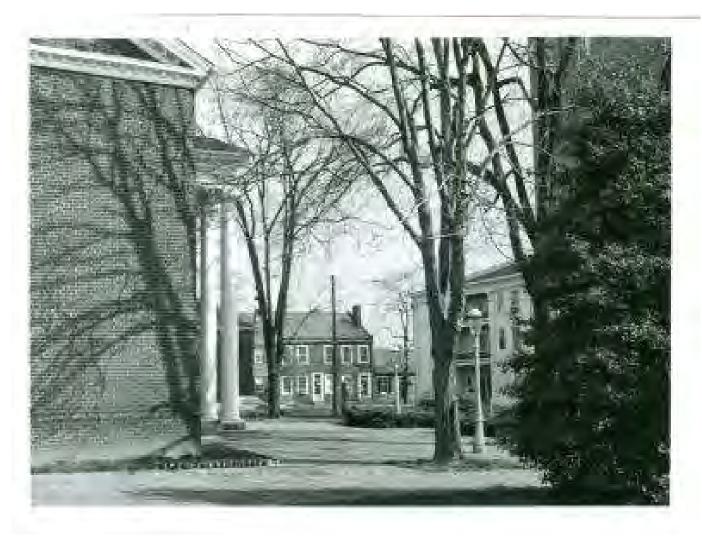
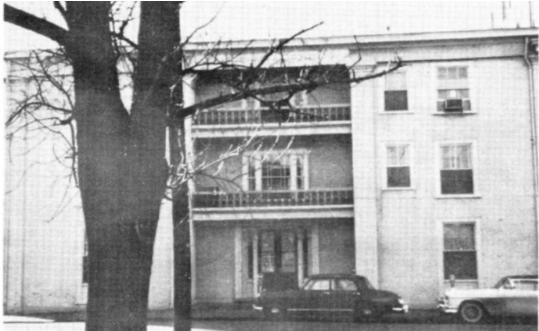
PHOTO 2A & 2B – HISTORIC PHOTOS OF BUILDING EXTERIOR HAVING BEEN PAINTED WHITE

- Repair and repoint all areas of failing brick examples of matching brick to be shown in meeting.
- Whitewash brick to conceal brick and mortar variation and to blend years and years of variating mortar repairs. Please see photos of both buildings having been painted white (photos 1, 2A, 2B)

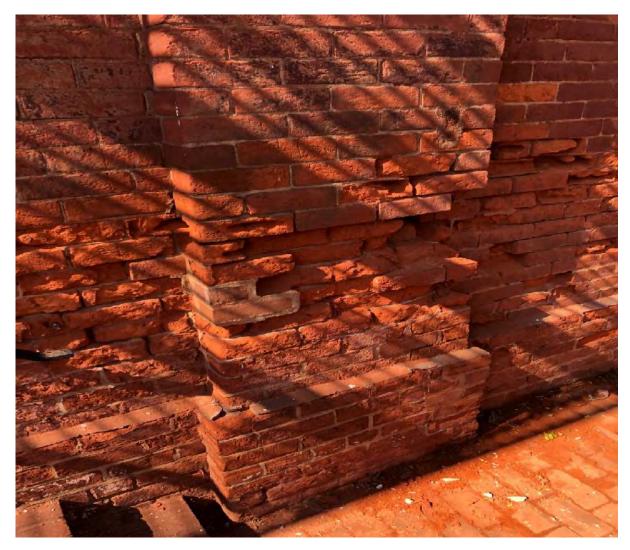
PHOTO 3 – FAILING BRICK CONDITION

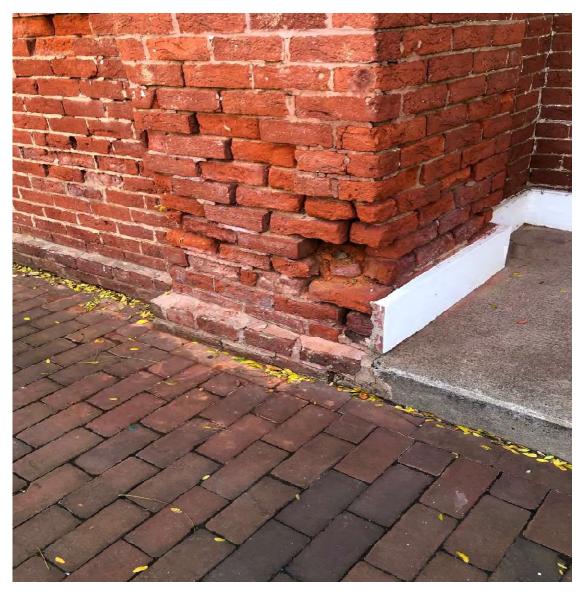
```
PHOTO 4 – FAILING BRICK CONDITION
```

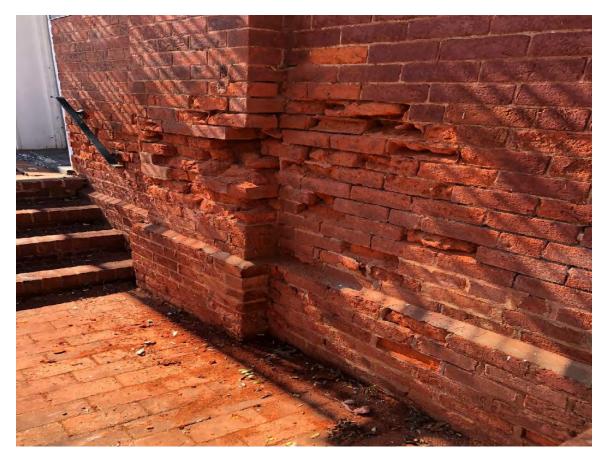
PHOTOS 9A & 9B – BRICK DETERIORATION ACTUAL CONDITIONS

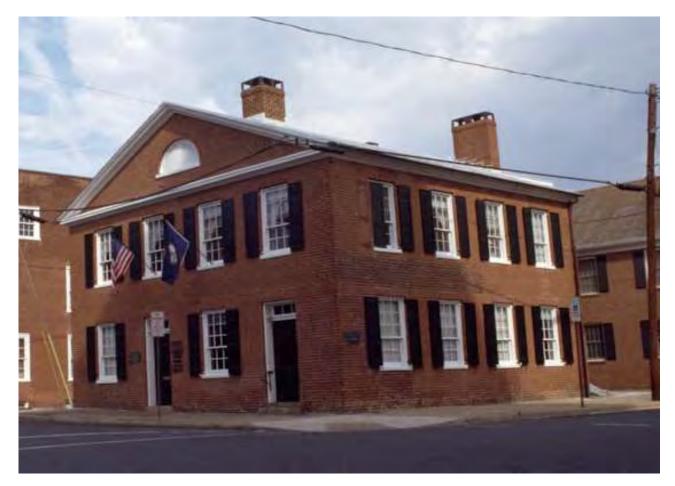
PHOTO 11A - SHUTTERS ON ZERO COURT SQUARE, CHARLOTTESVILLE. DIRECTLY ACROSS FROM 300 COURT SQUARE

- Brick is failing in many places, requesting ability to use a lime mortar sealant to stabilize the brick (photos 3-7, 9A, 9B &10).
- Install operable paneled shutters to match Zero Court Square's shutters on the North and East sides of the building (photos 11A, 11B, 12A & 12B)

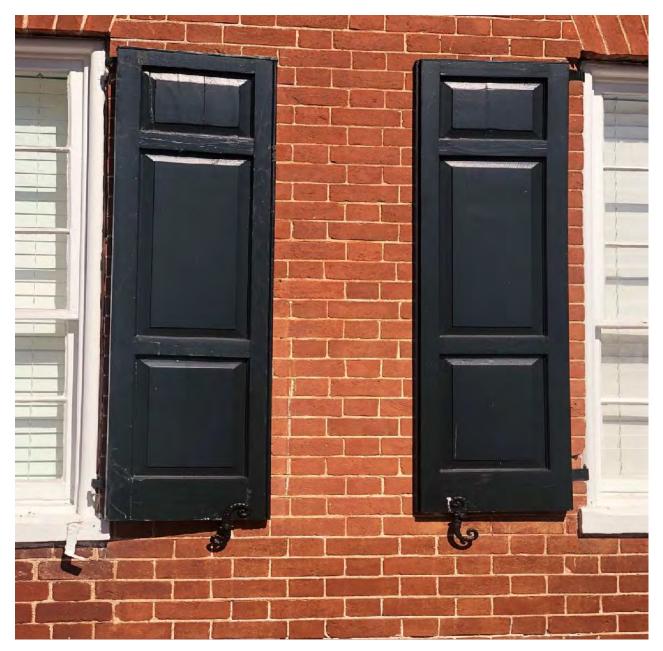
PHOTO 11B – PANELED SHUTTERS ON ZERO COURT SQUARE

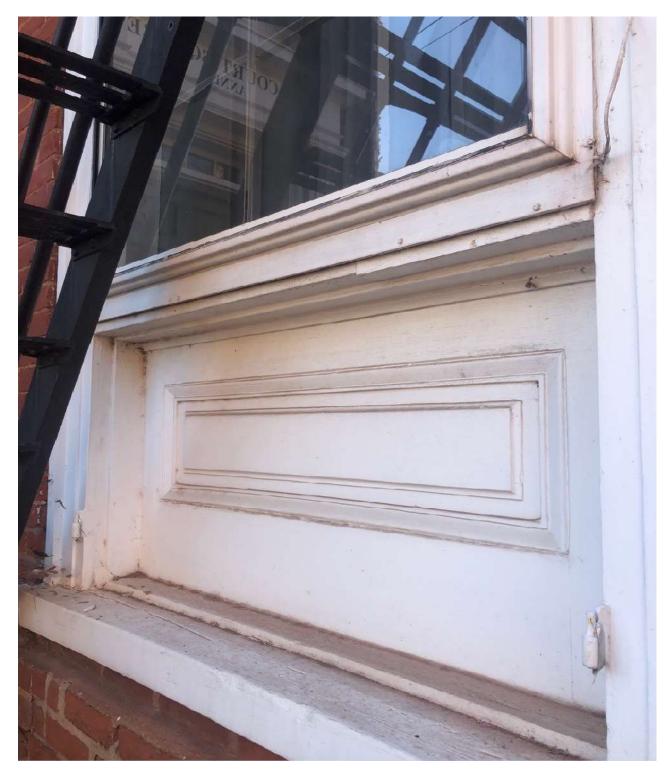
```
PHOTO 12 A – ORIGINAL SHUTTER PINS
```

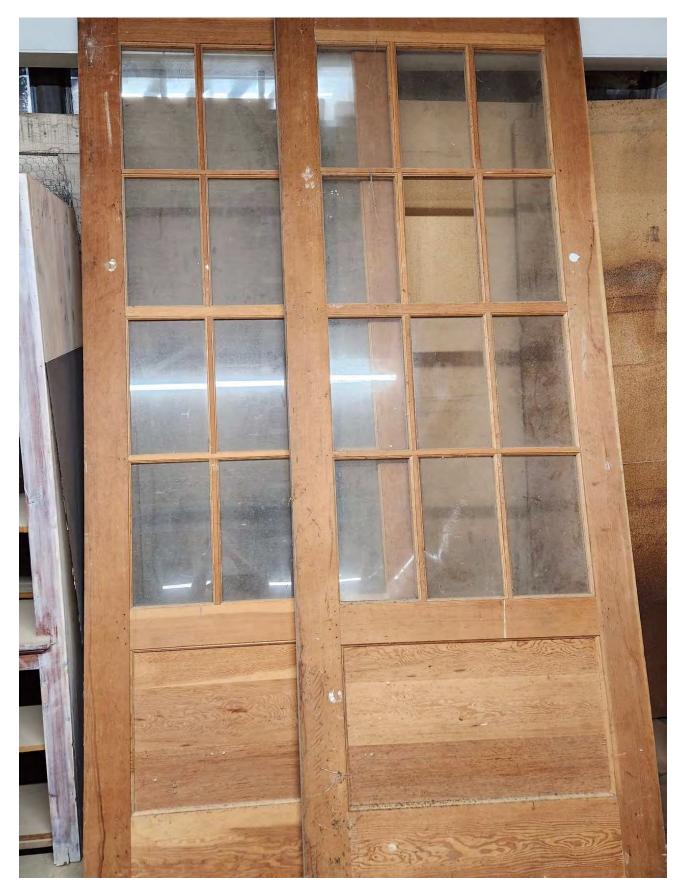
PHOTO 13 – GLASS FRONT ENTRY DOORS – FOUND IN THE BUILDING

- Install original historic 9' tall doors with upper true divided light panels doors were found in the building. (photo 13)
- Install original historic 9' tall six-paneled outer doors to be propped open doors were in building. (photo 14)

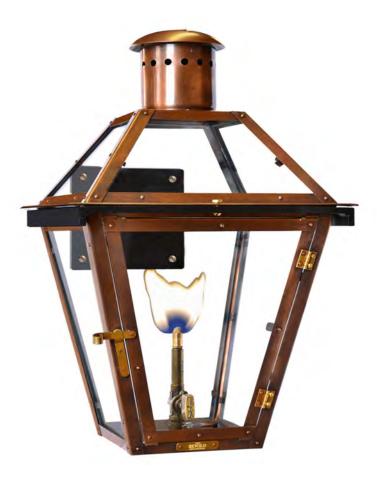
PHOTO 15 – WALL MOUNTED GAS LANTERN – "FRENCH QUARTER" BY BEVELO

- Balcony ceilings to be painted Dolphin Cove 722 Benjamin Moore. Please see sample on building.
- Install four handmade copper gas lanterns flanking windows: French Quarter Lantern by Bevelo. (photo 15)

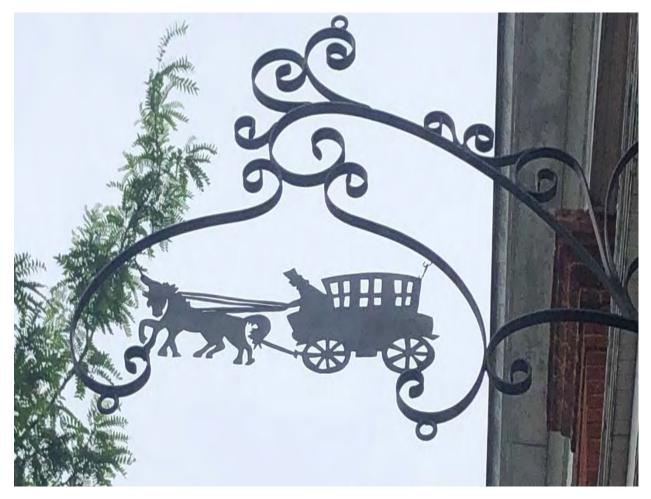
PHOTO 17 – HISTORIC STEEL SIGN TO BE HUNG WEST OF FRONT ENTRY DOORS

- Install four low-watt down lights to illuminate top of pilasters
- "THE ZEBRA CARRIAGE HOTEL" to be painted in black lettering on front top cornice
- Signage is a vintage steel bracket and sign. (photo 17)

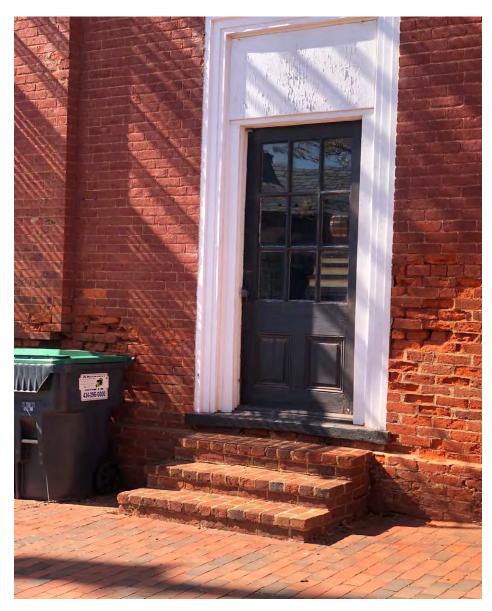
PHOTO 19 – REMOVE DOOR AND STEPS TO RIGHT OF PORTICO – REPLACE WITH ORIGINAL WINDOW

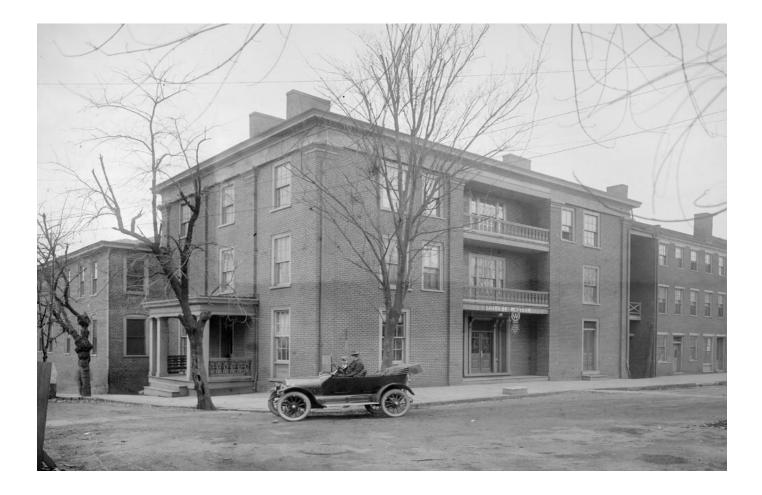
PHOTO 20 - ORIGINAL PORTICO AND ORIGINAL WINDOW TO NORTH OF PORTICO

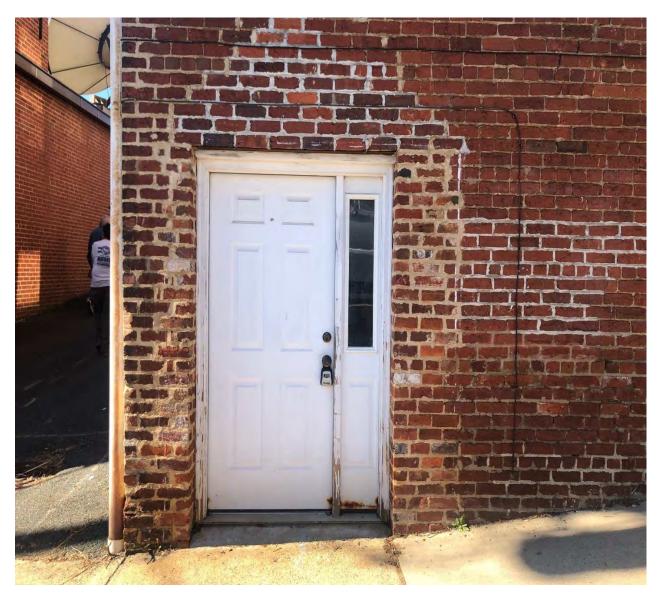
PHOTO 23 - EXISTING 6<sup>TH</sup> STREET DOOR TO FUTURE GIFT STORE – TO BE REMOVED AND REPLACED WITH 15-LIGHT DOUBLE DOORS SHOWN BELOW

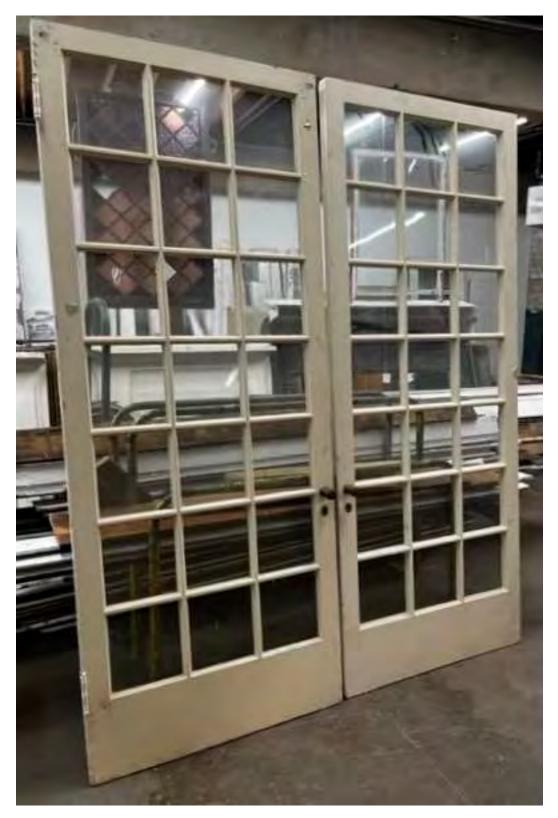
PHOTO 24 - DOORS TO BE USED FOR ENTRY TO GIFT STORE ON 6<sup>TH</sup> STREET AND FROM BALLROOM TO TERRACE

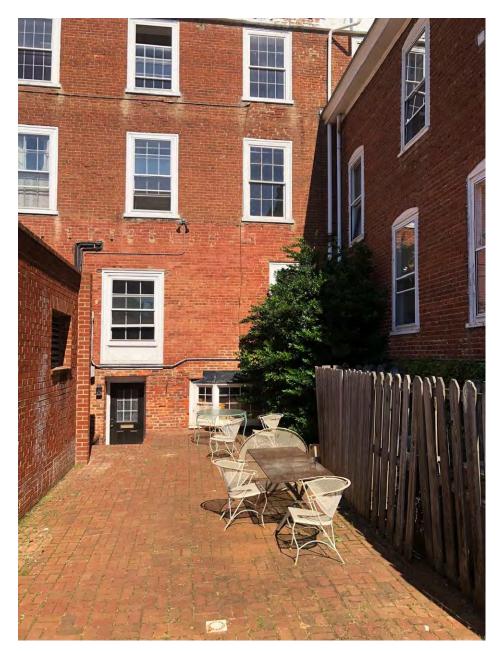
PHOTO 25 - NEW FRENCH DOORS TO BE LOCATED BETWEEN LOWER WINDOWS.

DECK ADDED AT LEVEL OF THE DOORS

- Replace mismatched, un-original windows with matching windows
- A glass and wood door to match the windows will be installed in the center for emergency egress and to access the deck. (photo 24 & 25)

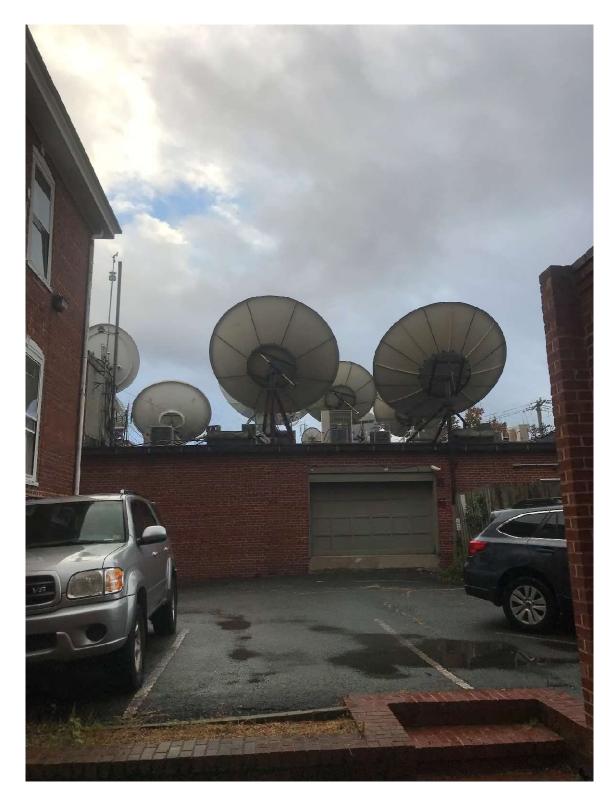
PHOTO 27 - VIEW OF SATELLITE DISHES FROM SOUTH FACING WINDOWS

- An arbor will be built over head to screen the huge amount of satellite dishes on the roof of the 29 building. This is a major eyesore and a big obstacle to overcome. (photos 27, 28 & 29)

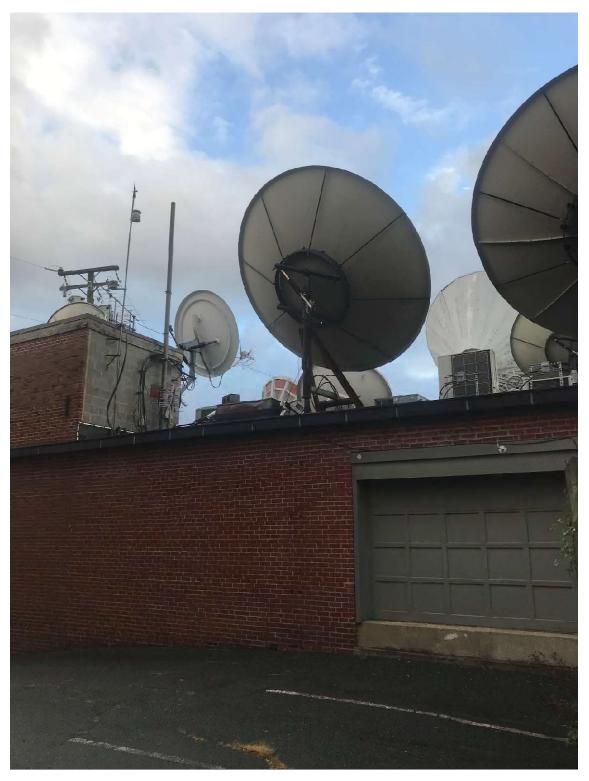
PHOTO 28 - VIEW OF SATELLITE DISHES FROM COURTYARD – TERRACE ESSENTIAL TO BLOCK THESE EYESORES

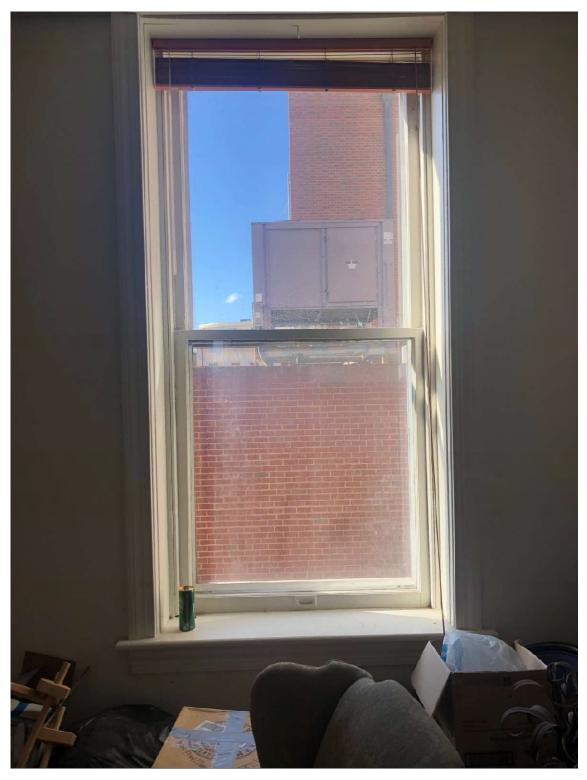
PHOTO 29 - VIEW OF AC CHILLER FROM "ANNEX ROOMS"

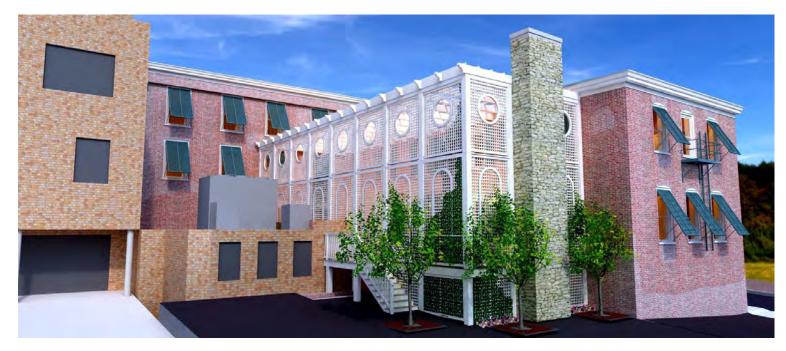
PHOTO 26 - DECK WITH ARBOR AND TRELLIS TO BE BUILT TO OBSURE SATELLITE DISHES AND AC CHILLER

- A two-story trellised wall will be built against the neighboring equipment building to hide the AC chiller on top. (photo 26)
- A wooden deck will be built to the same level as the first-floor ballroom. (photo 26)

- A retractable glass roof will be installed just below the eves so events can occur during inclement weather.
- A two-story stone chimney will be the focal point of the terrace and act to screen the satellite dishes (photo 26)

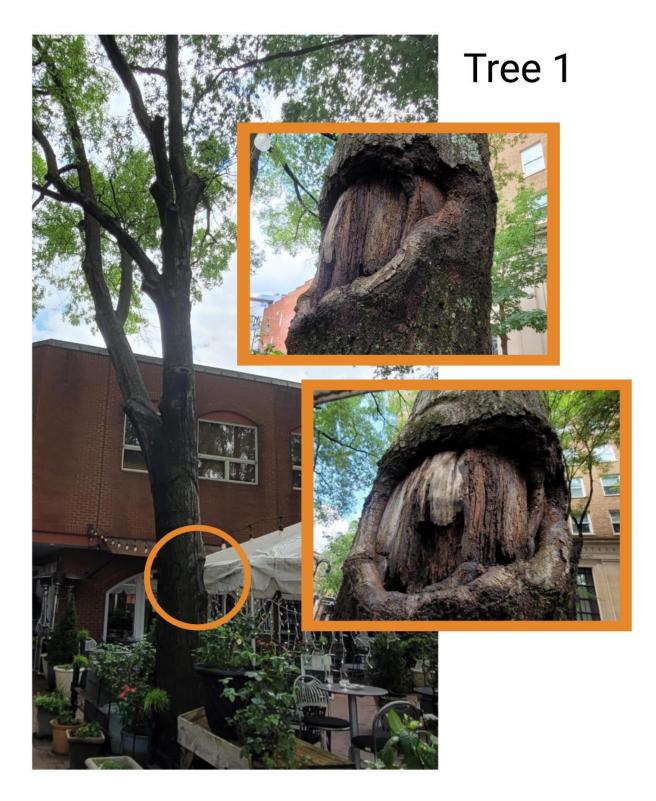
<u>Tree 1</u>

Figure 1: Large Diameter Willow Oak 24-26 inches in diameter. Significant wound starting approximately 5 feet up on tree bole. Obvious internal decay with carpenter ant activity.

Location: Dining area – Petit Pois

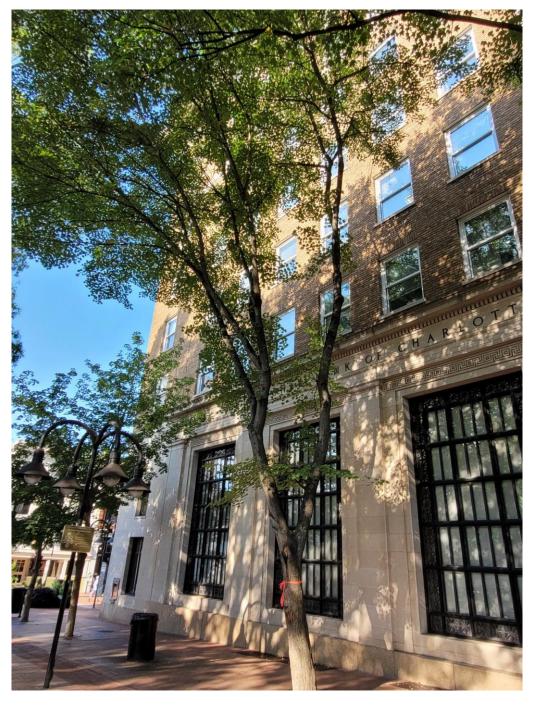
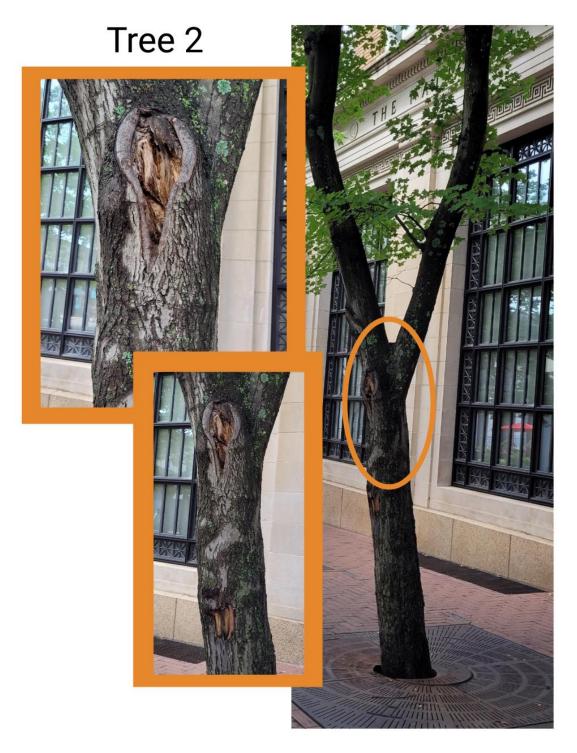
#### <u>Tree 2</u>

Figure 2: Red Maple, approximately 12 inches in diameter. Two significant wounds on tree bole (Approximately 4 feet high and 7 feet high respectively). Obvious internal decay at crotch, with additional infection evident in wilting leaves (probably Verticillium Wilt – unconfirmed currently). Location: Adjacent to Dining area – Petit Pois

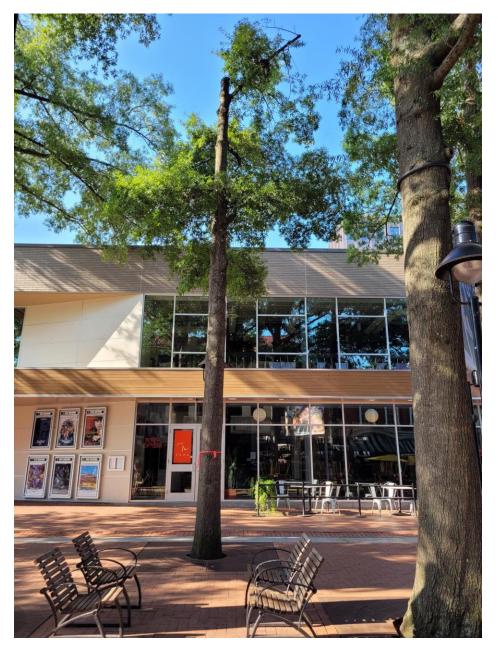
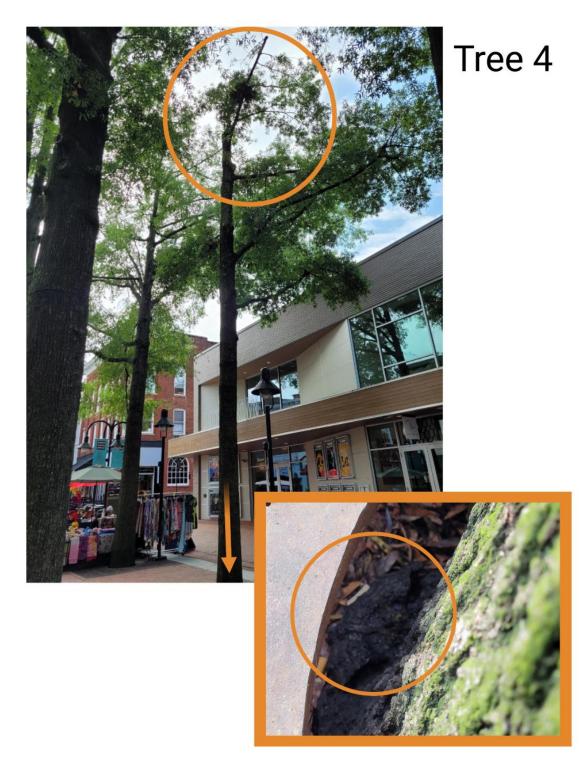
#### <u>Tree 4</u>

Figure 4: Willow Oak tree, approximately 12-14 inches in diameter. Tree displaying a few dead limbs in the upper canopy as well as large fruiting body on the stump (common indicator of severe internal decay). This tree has been heavily pruned over the years and is showing loss of vigor. Location: Across from Rockfish Brewing Company.

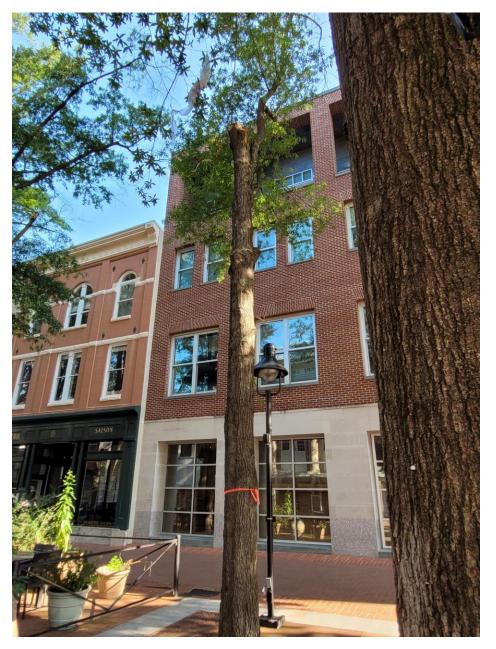
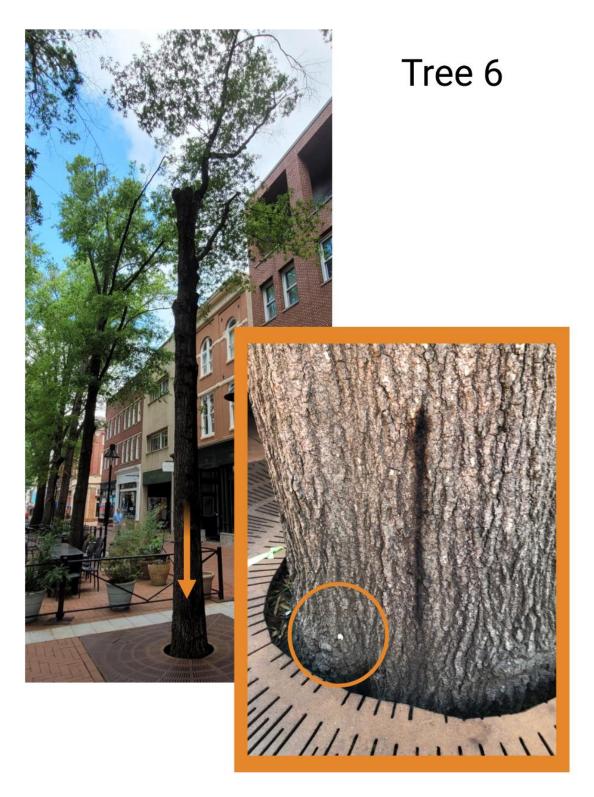
#### <u>Tree 6</u>

Figure 6: Willow Oak tree, approximately 14-16 inches in diameter. Tree has several dead limbs in the upper canopy and has been intensively pruned in the past. Tree displays fungal fruiting bodies toward the top branches, as well as bacterial weeping, both indicating internal decay. Location: Across from Wells Fargo Bank.

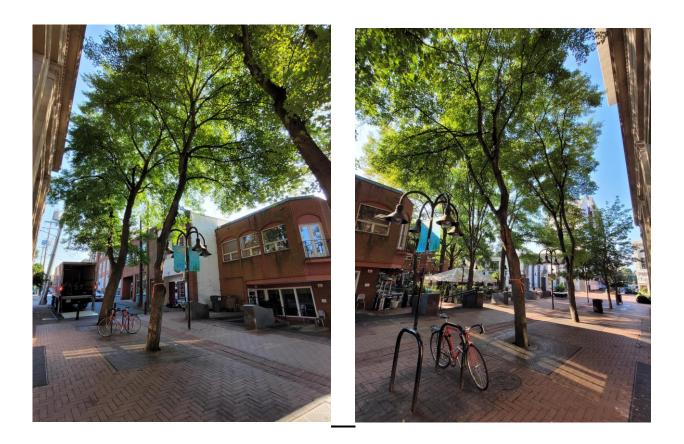
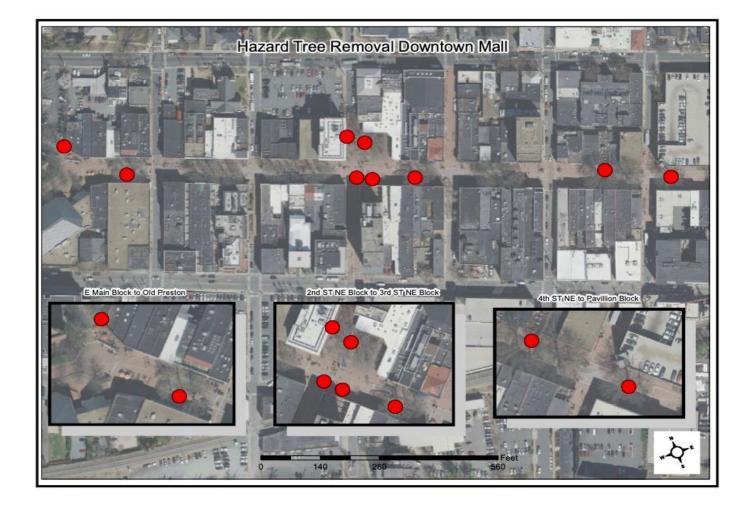
### <u>Tree 11</u>

Tree 11: Red maple tree displaying two significant wound sites as well as significant decay. The structural integrity of the tree is compromised and should be removed. Suggest replacing tree with a more appropriate species that will contribute to shade services and pedestrian safety.

Tree location: Adjacent to fountain on downtown mall.
