Packet Guide
City of Charlottesville
Board of Architectural Review
Regular Meeting
December 20, 2022, 5:30 p.m.
Hybrid Meeting (In-person at CitySpace and virtual via Zoom)

Project: Porch reconstruction, alterations to rear addition

Project: Replace built-in gutters w/hanging gutters, install new asphalt shingles.

Project: New residence on vacant lot

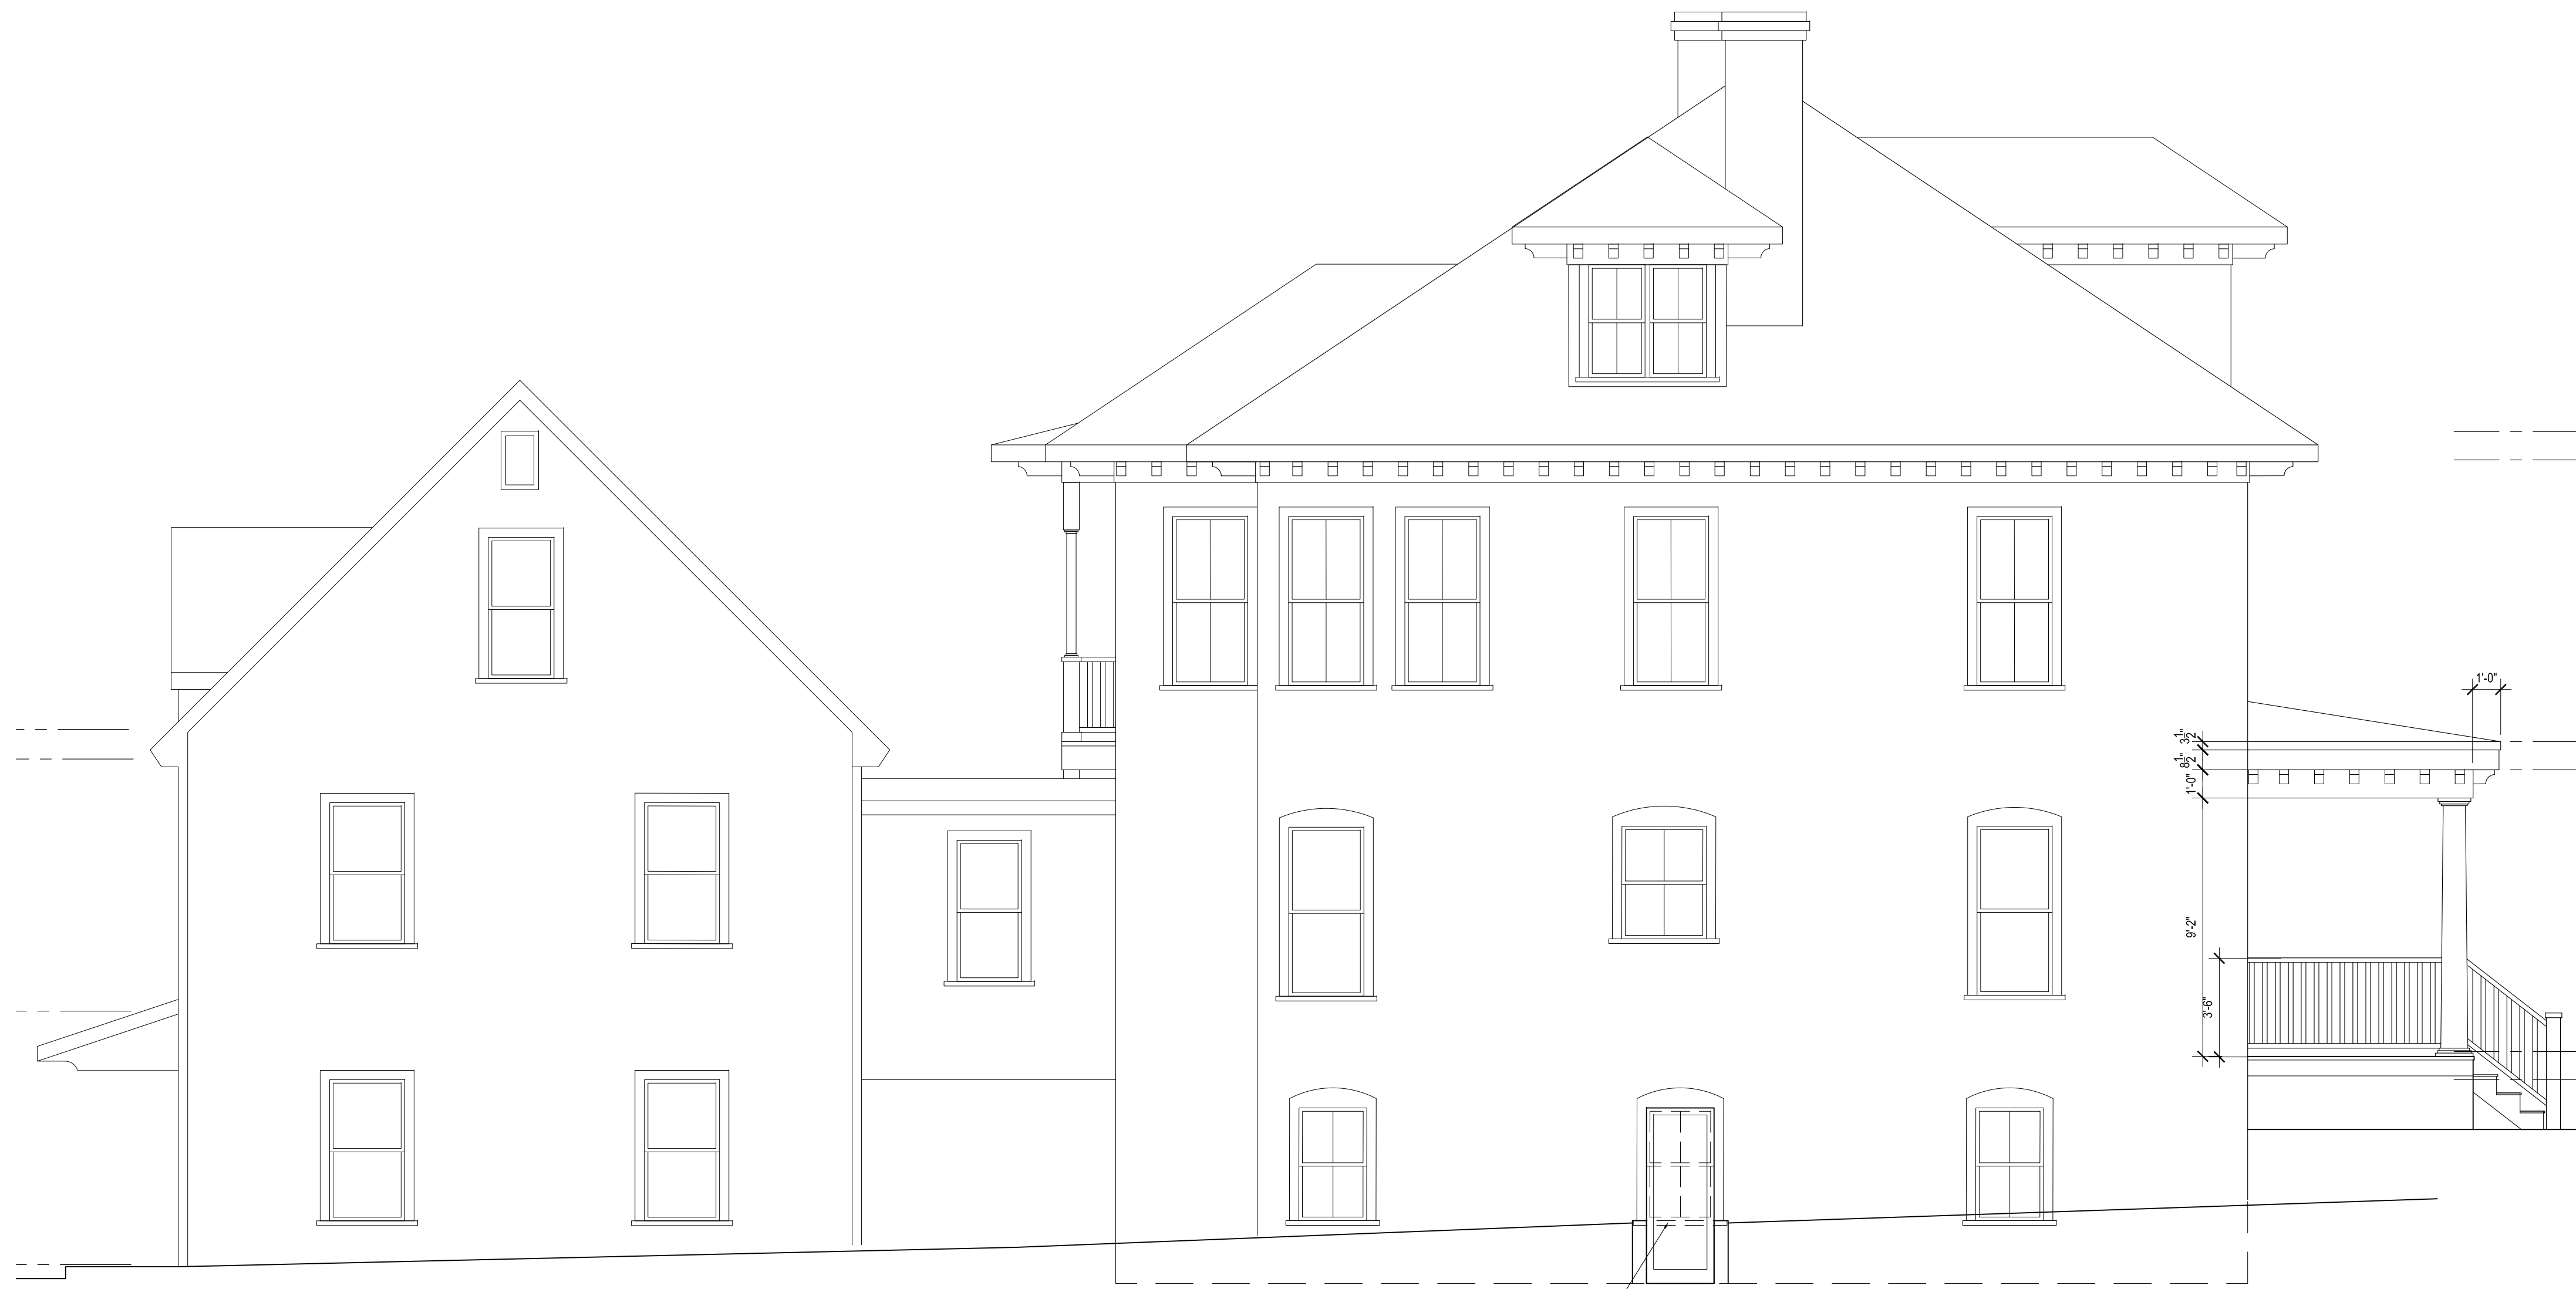
EXTERIOR ELEVATION - EAST
116 WEST JEFFERSON STREET

NEW DOOR AT EXISTING WINDOW LOCATION,
PAINTED 6-PANEL WOOD DOOR TO MATCH EXISTING.

New French door at rear porch (1st floor) and new six-panel door at the east elevation (basement) of 1913 house: Staff recommends approval with the following condition of approval:

- On the 1913 house, the two new doors (frame and trim) will not alter the height, arch, or width of the existing masonry opening. Necessary brick repairs will be toothed-in, not saw cut, and use an appropriate mortar mix (lime vs Portland cement). The historic windows removed will be retained on the site and properly stored to allow later re-installation, if/when that occurs.

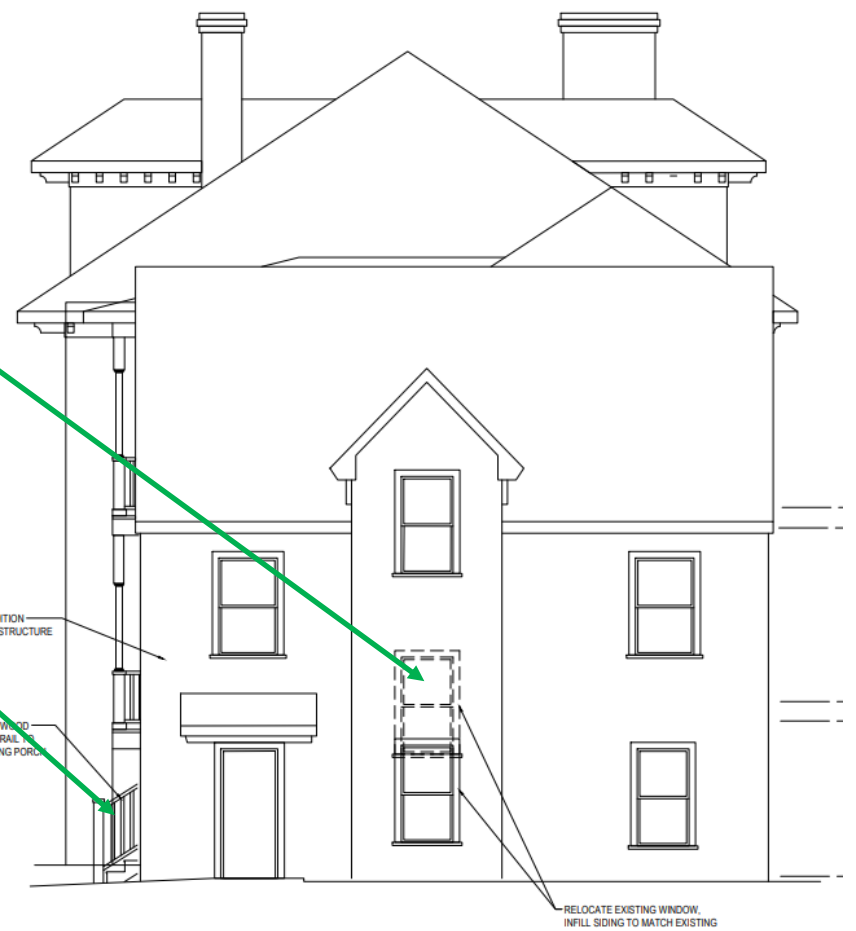
(New stairs at
connector)

EXISTING ADDITION
TO HISTORIC STRUCTURE

NEW PAINTED WOOD
STAIR, GUARDRAIL, ETC.
MATCH EXISTING PORCH

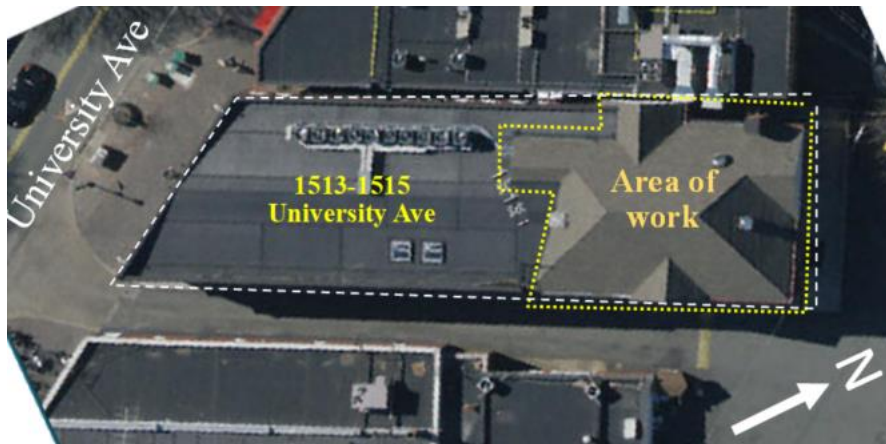
Staff recommends approval with a condition that the new hanging gutters will retain the existing profile of the upper cornice, per the rough sketch below. (Similar to the CoA condition applied to the porch roof at 201 E. High Street, July 2019.)

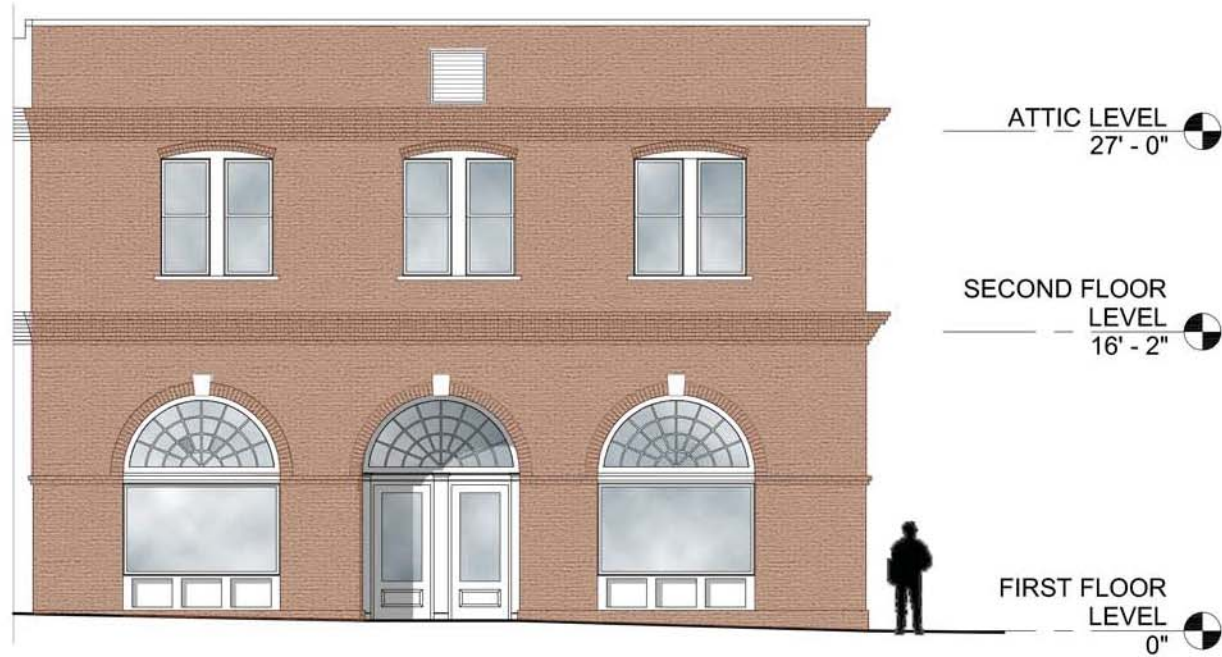
Existing South Elevation

Replace asphalt shingle roof in-kind with architectural shingles.

Remove Philadelphia gutter, install 1/2 round hanging gutter, painted white to match trim.

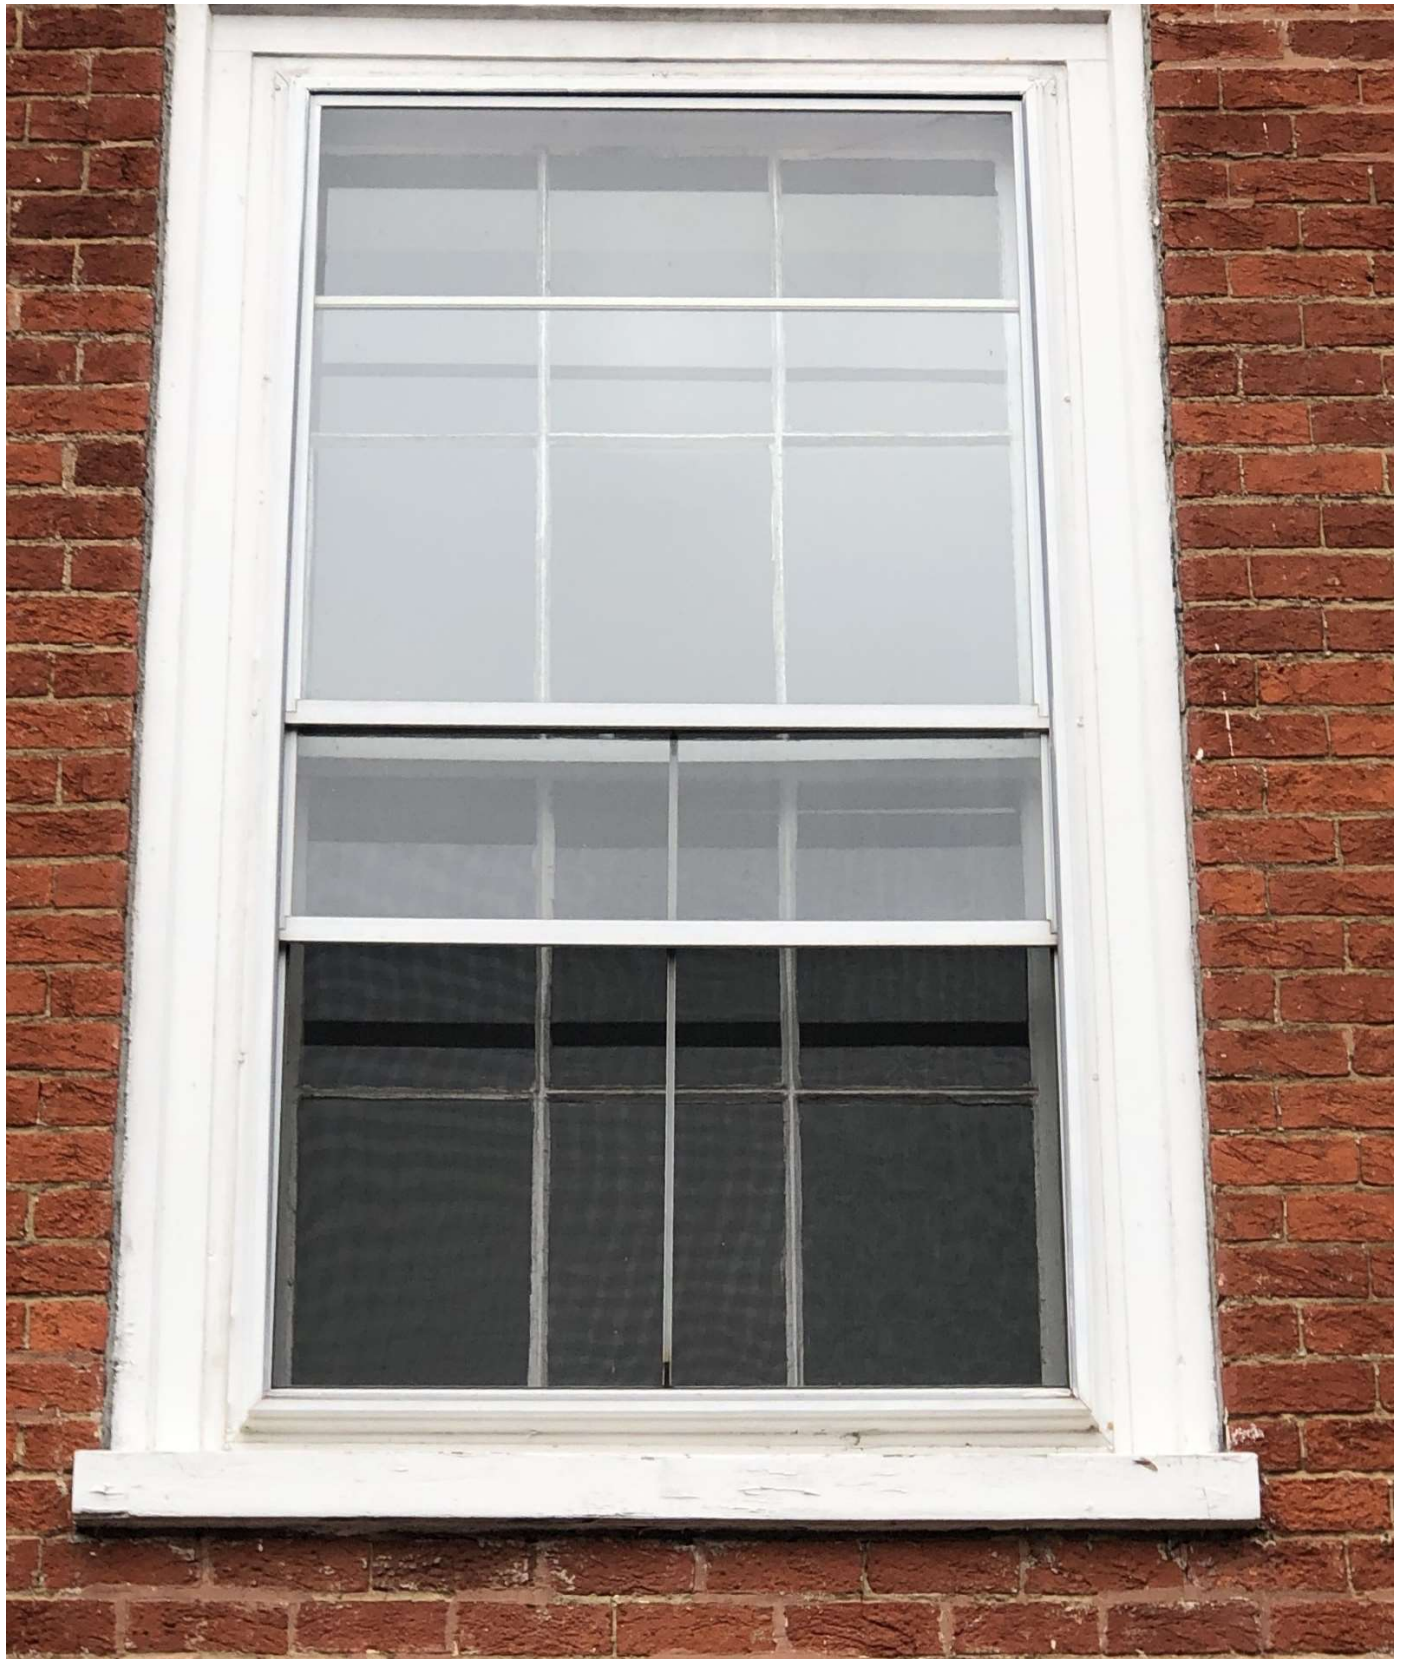
PHOTOS 1 -4 ORIGINAL WINDOW – NOTE MORTAR AT EDGES

UNORIGINAL WINDOW – NOTE MORTAR AT EDGES

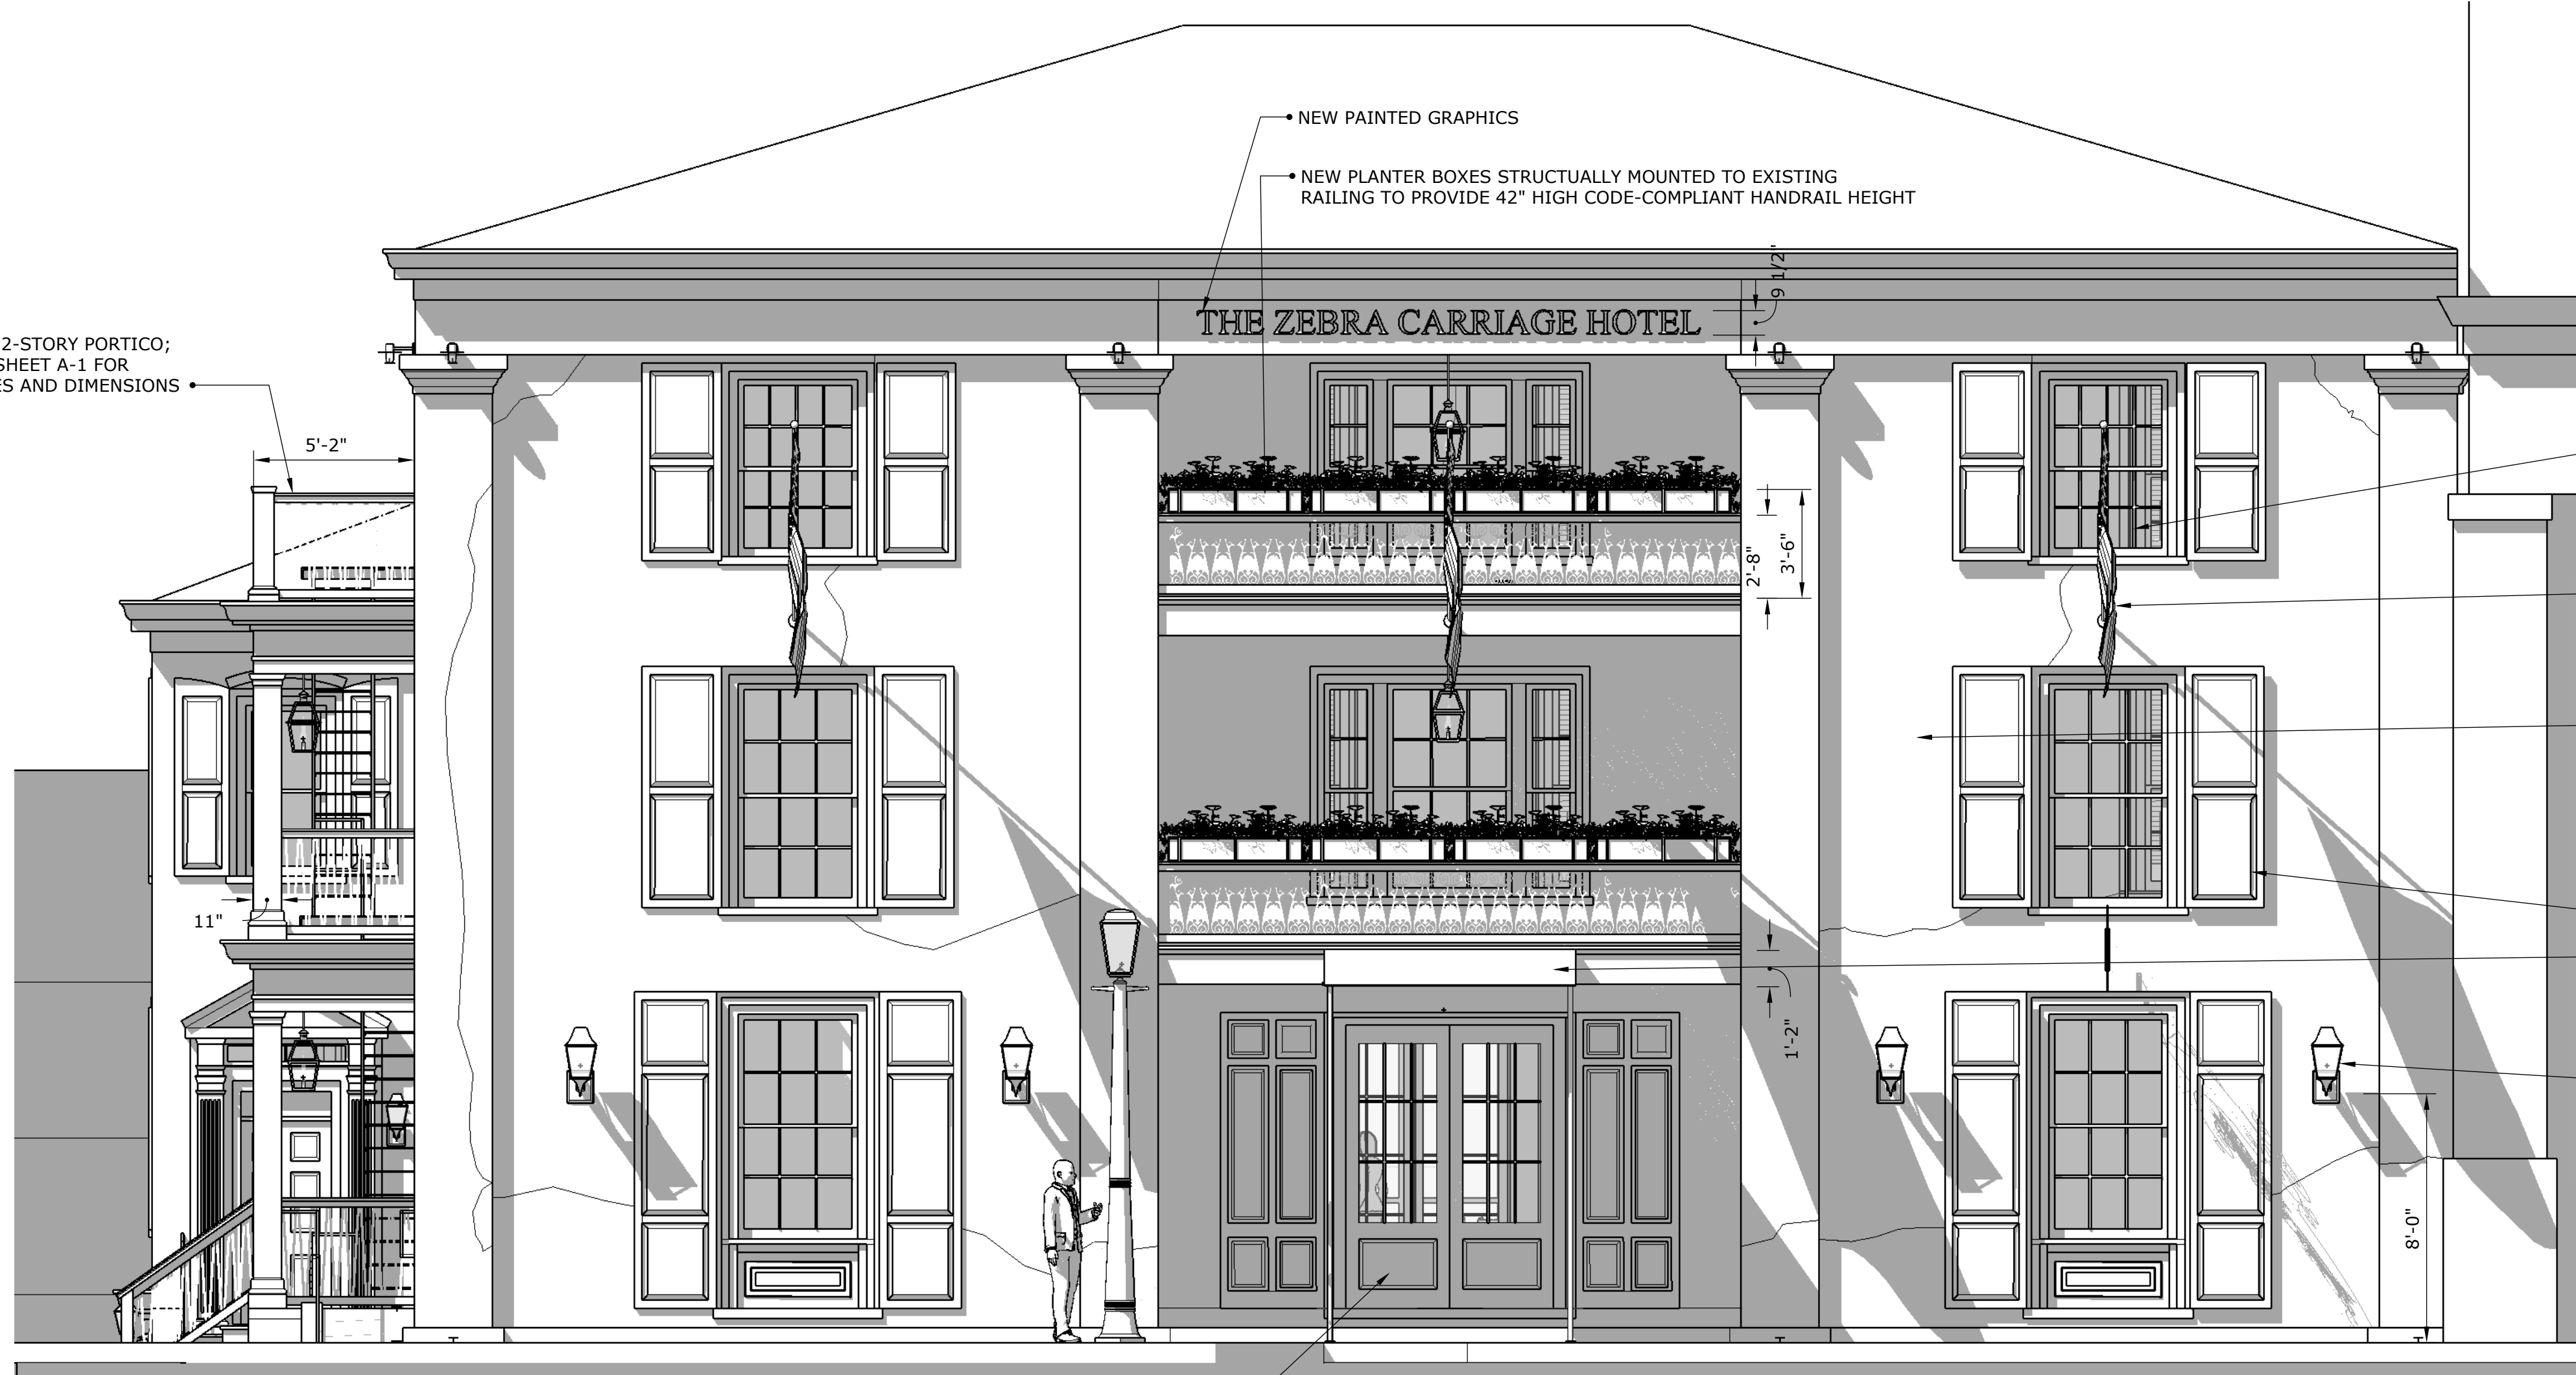
1 NORTH ELEVATION
A2 1/4"=1'-0"

NEW 2-STORY PORTICO;
SEE SHEET A-1 FOR
NOTES AND DIMENSIONS

REPLACE EXISTING DOORS WITH HISTORIC FRENCH DOORS

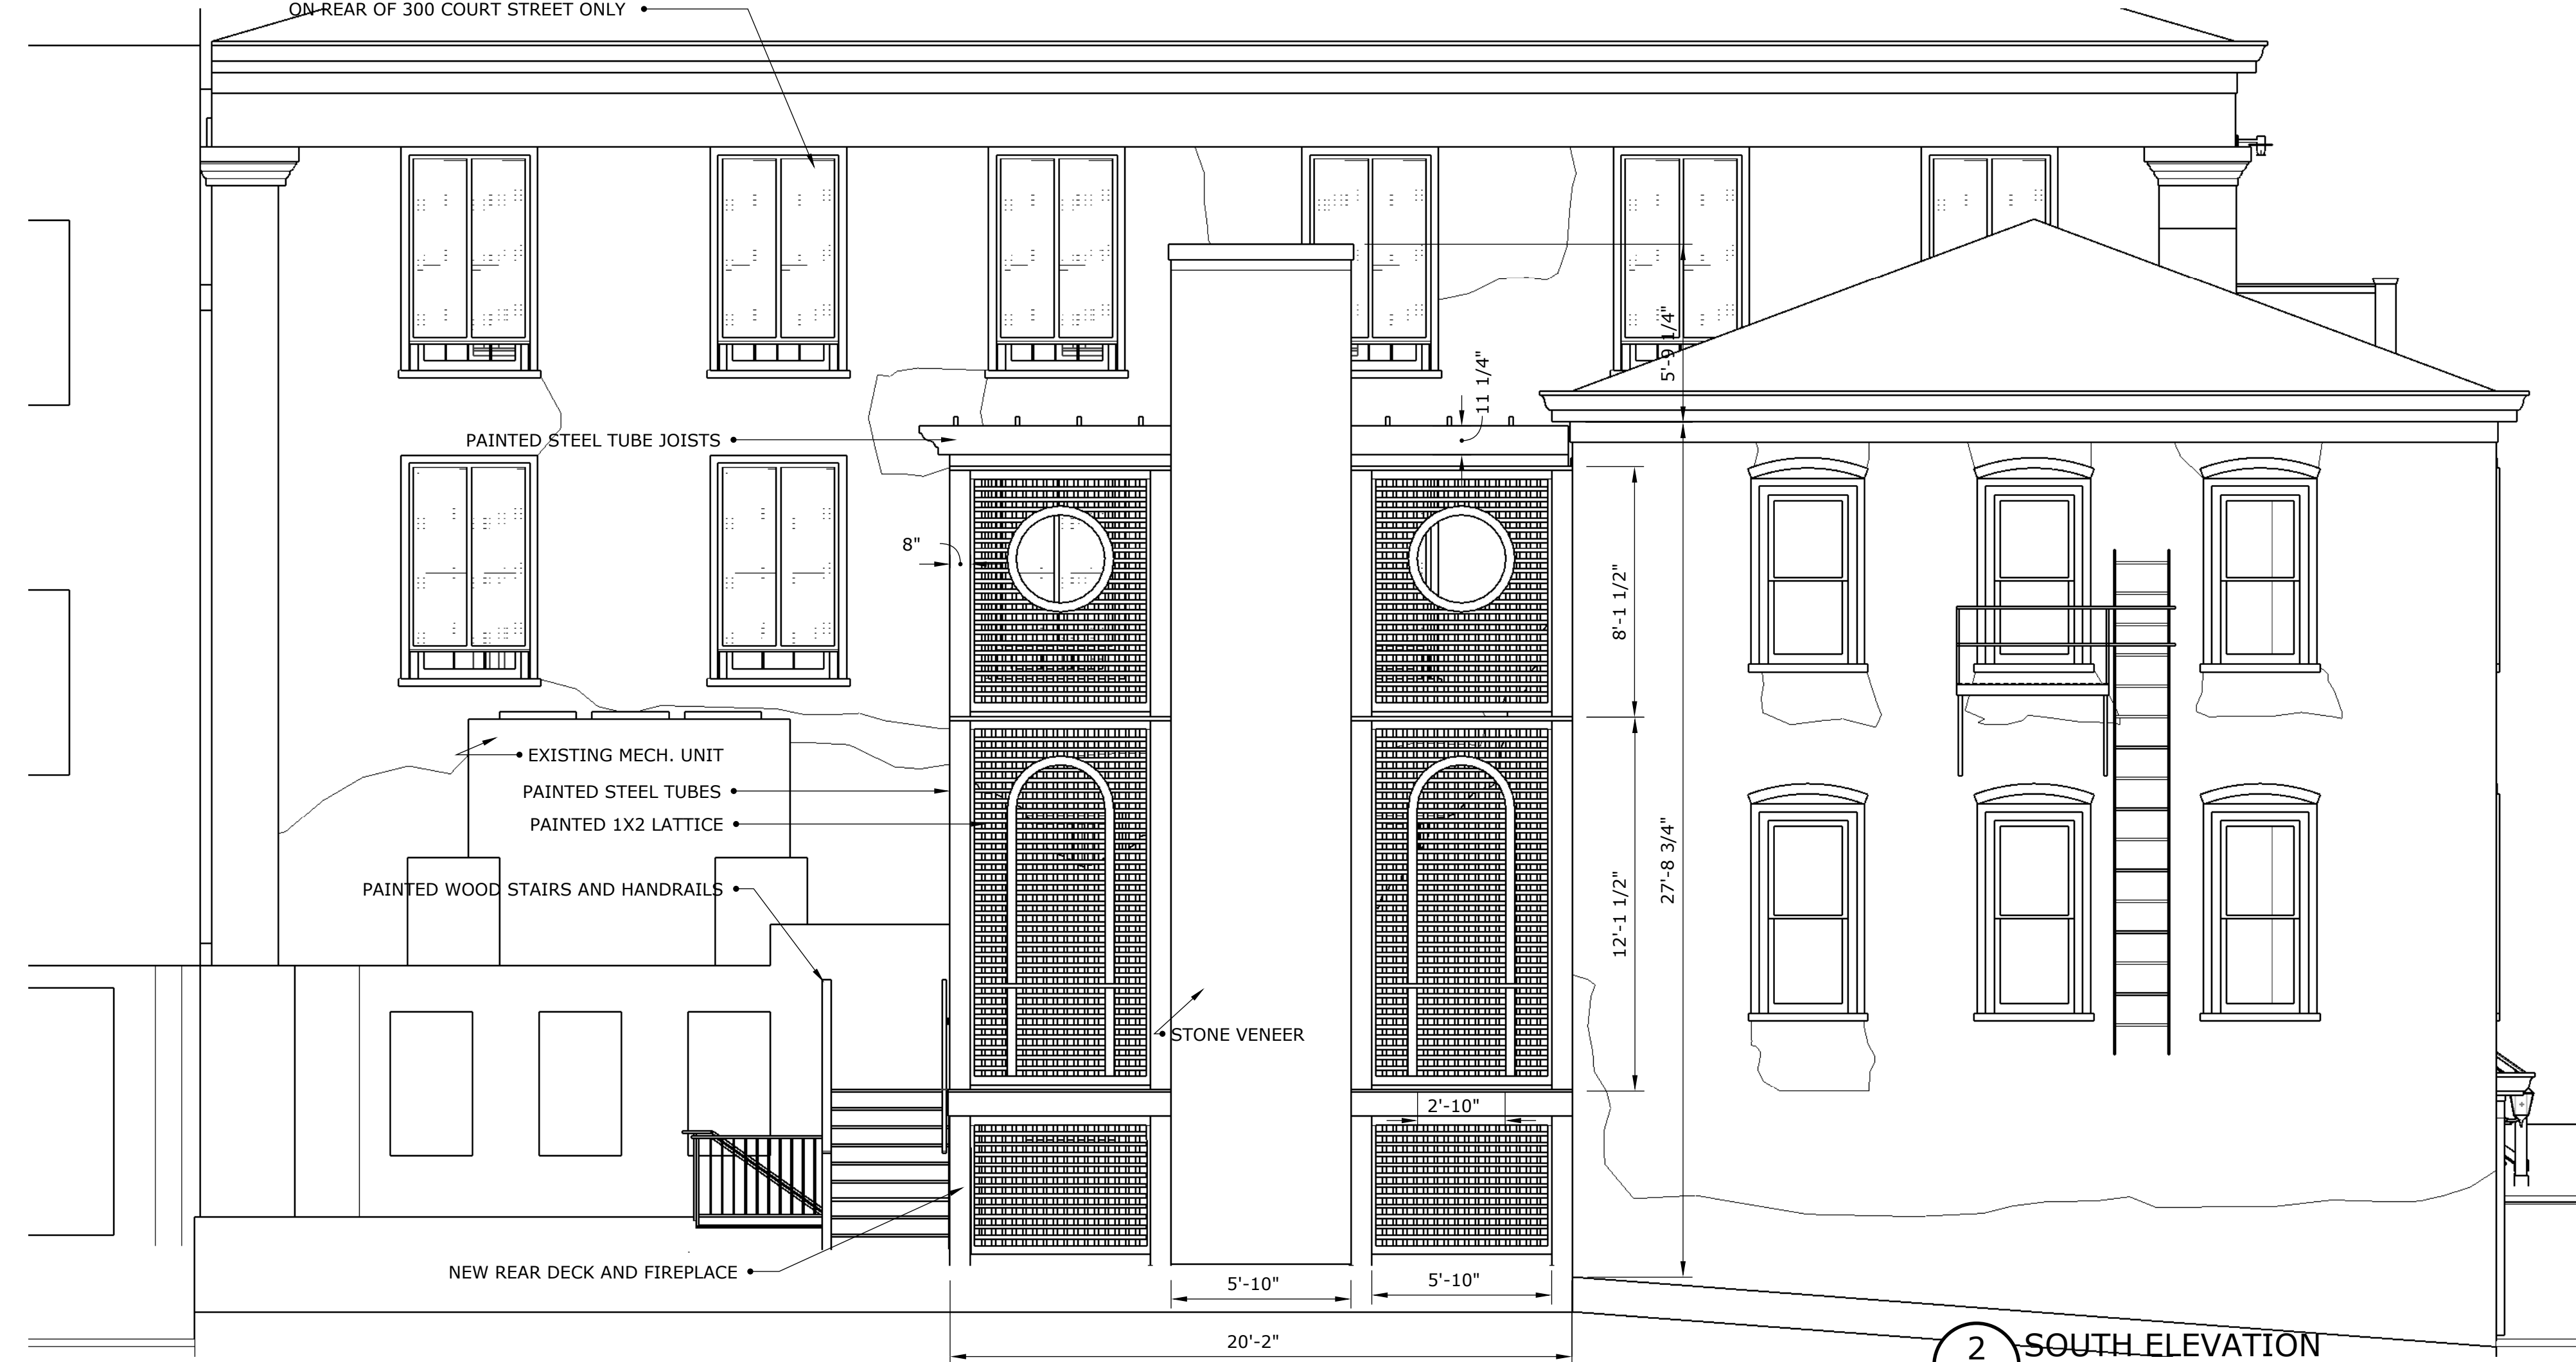
2 SOUTH ELEVATION
A2 1/4"=1'-0"

NEW GAS LANTERNS

NEW CUSTOM PTD. WOOD BERMUDA SHUTTERS
ON REAR OF 300 COURT STREET ONLY

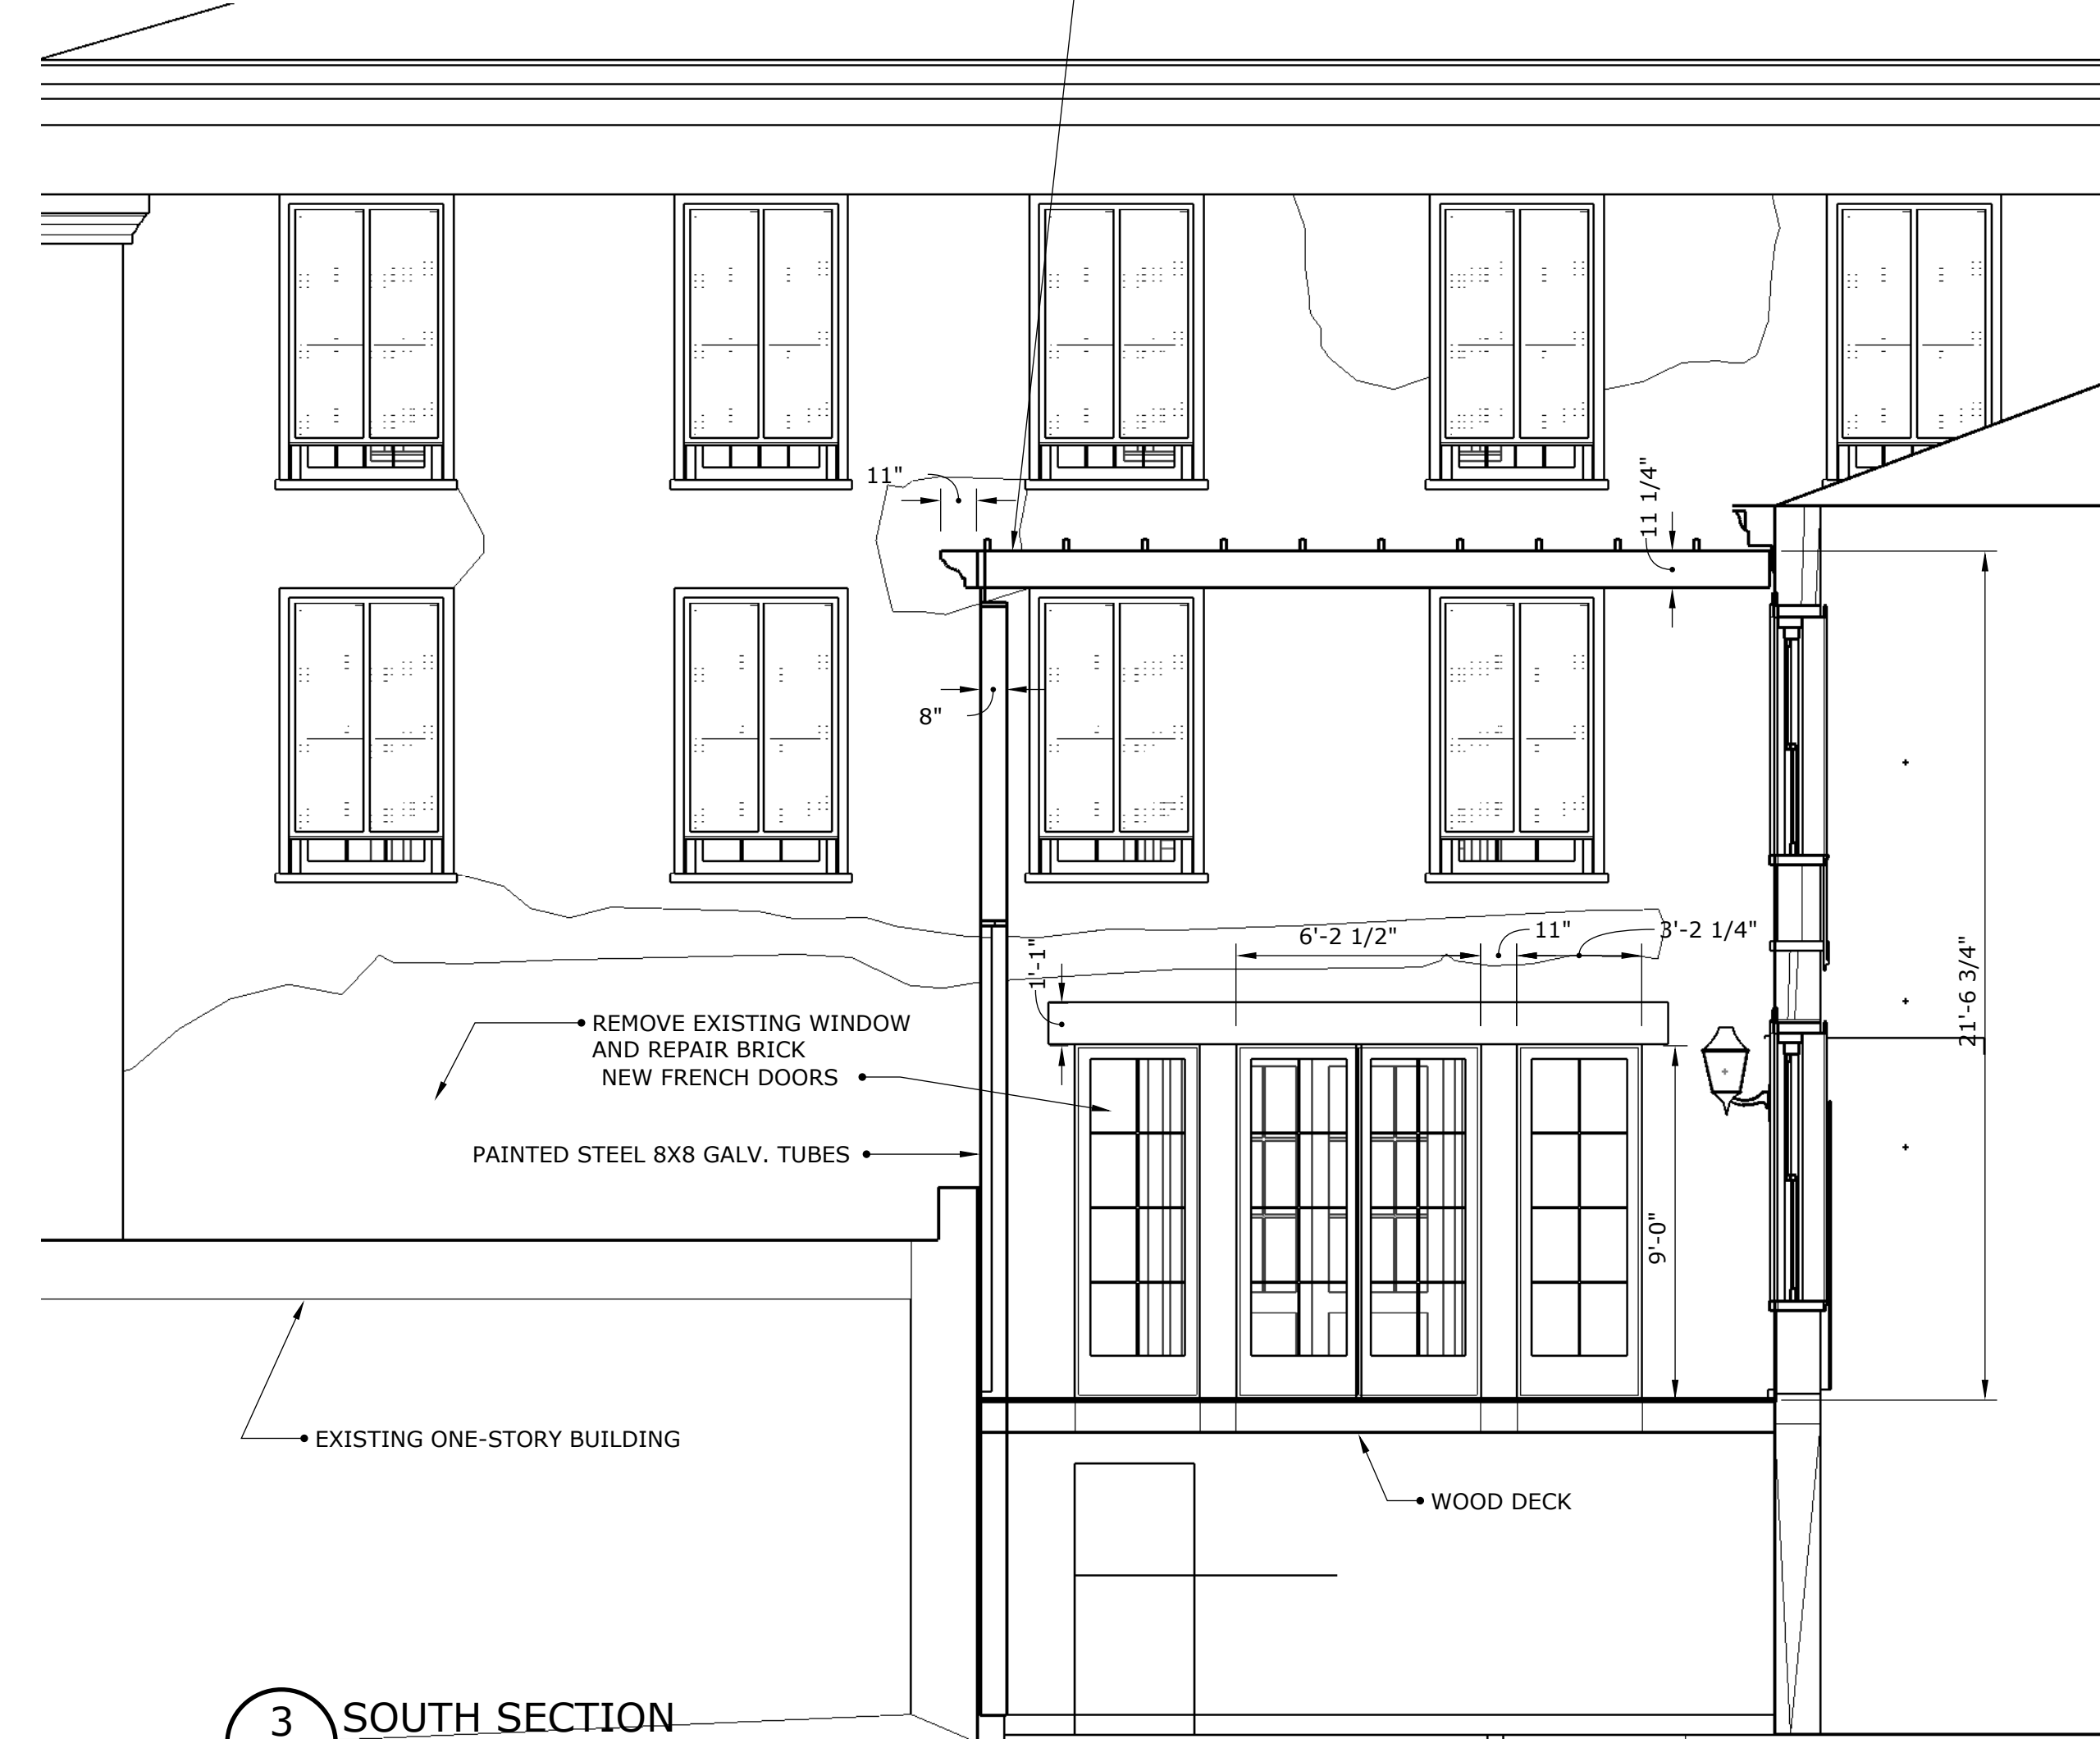
3 SOUTH SECTION
A2 1/4"=1'-0"

PAINTED STEEL TRELLIS JOISTS 2X12 GALV. STL. TUBE
